Excavations at

Britomart

Auckland (R11/1379)

Site Report for Auckland City Council
2005

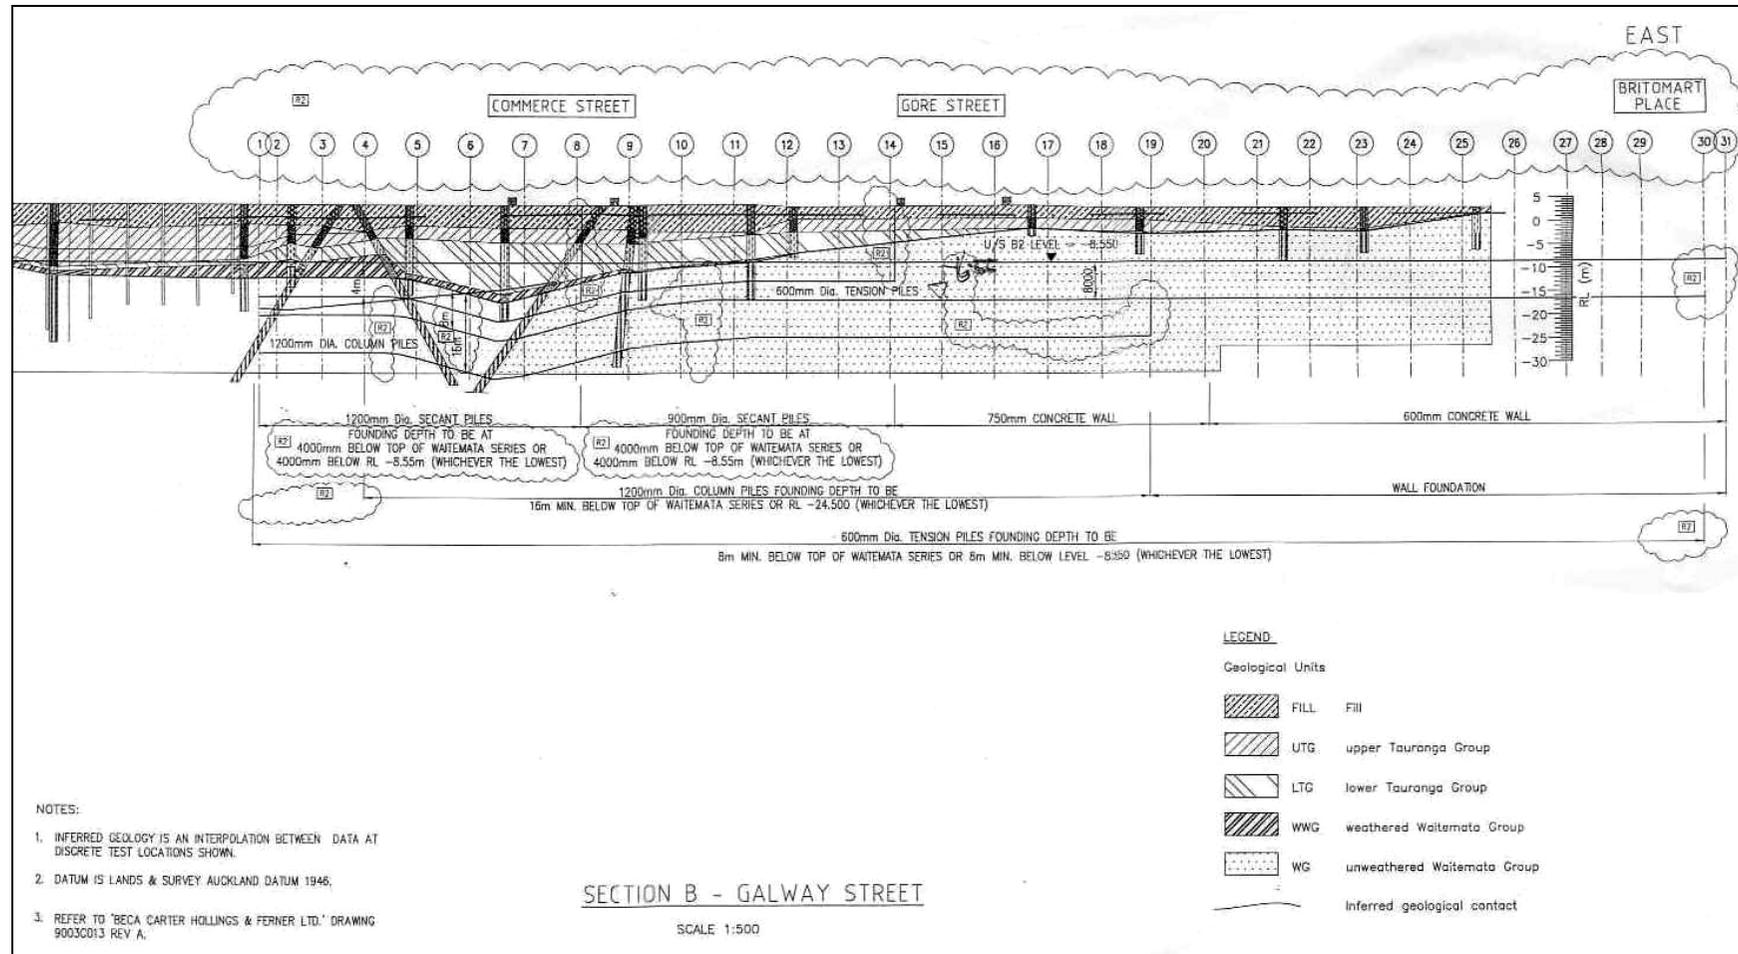
Figure 12. Geological cross section at Galway St based on geotechnical cores (courtesy Opus International)

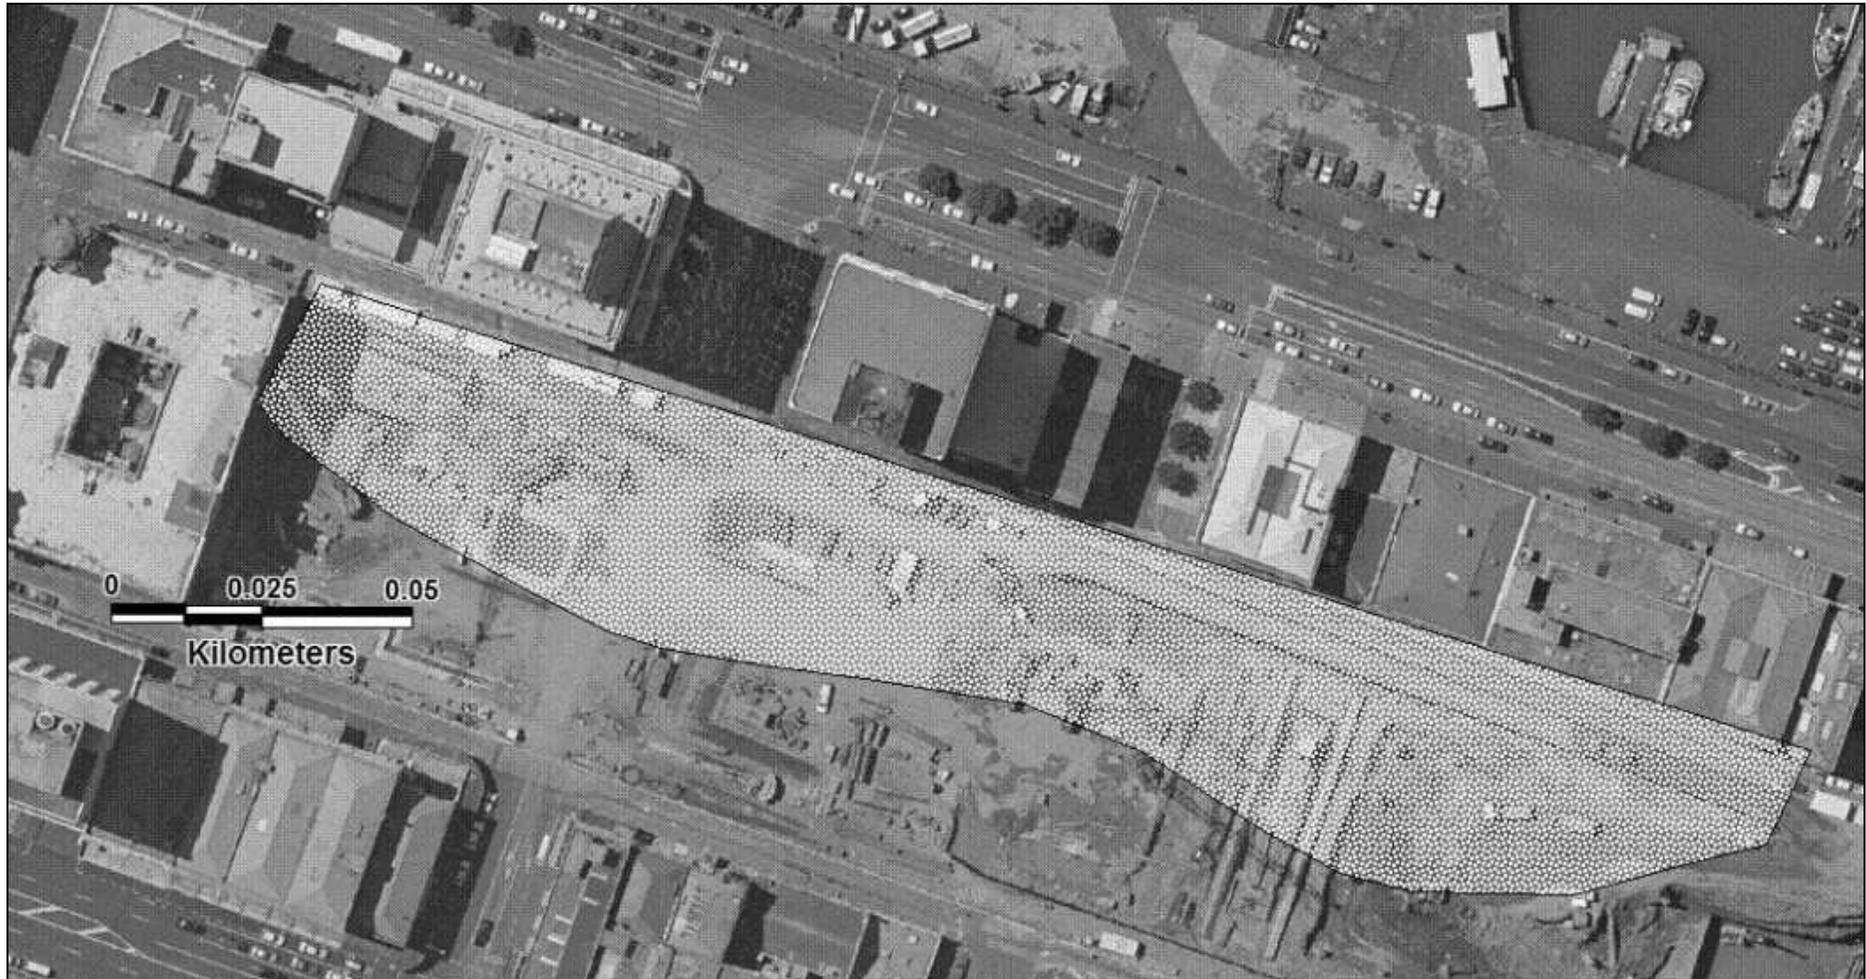
Figure 13. Shaded area where dredging was visible from excavations

During the earthworks marine sediments containing shell and harbour debris were observed, particularly in the northern third of the project area. This dredged material underlay the dumping from the industries and residences in the area. This zone of dredging is shown in Figure 13.

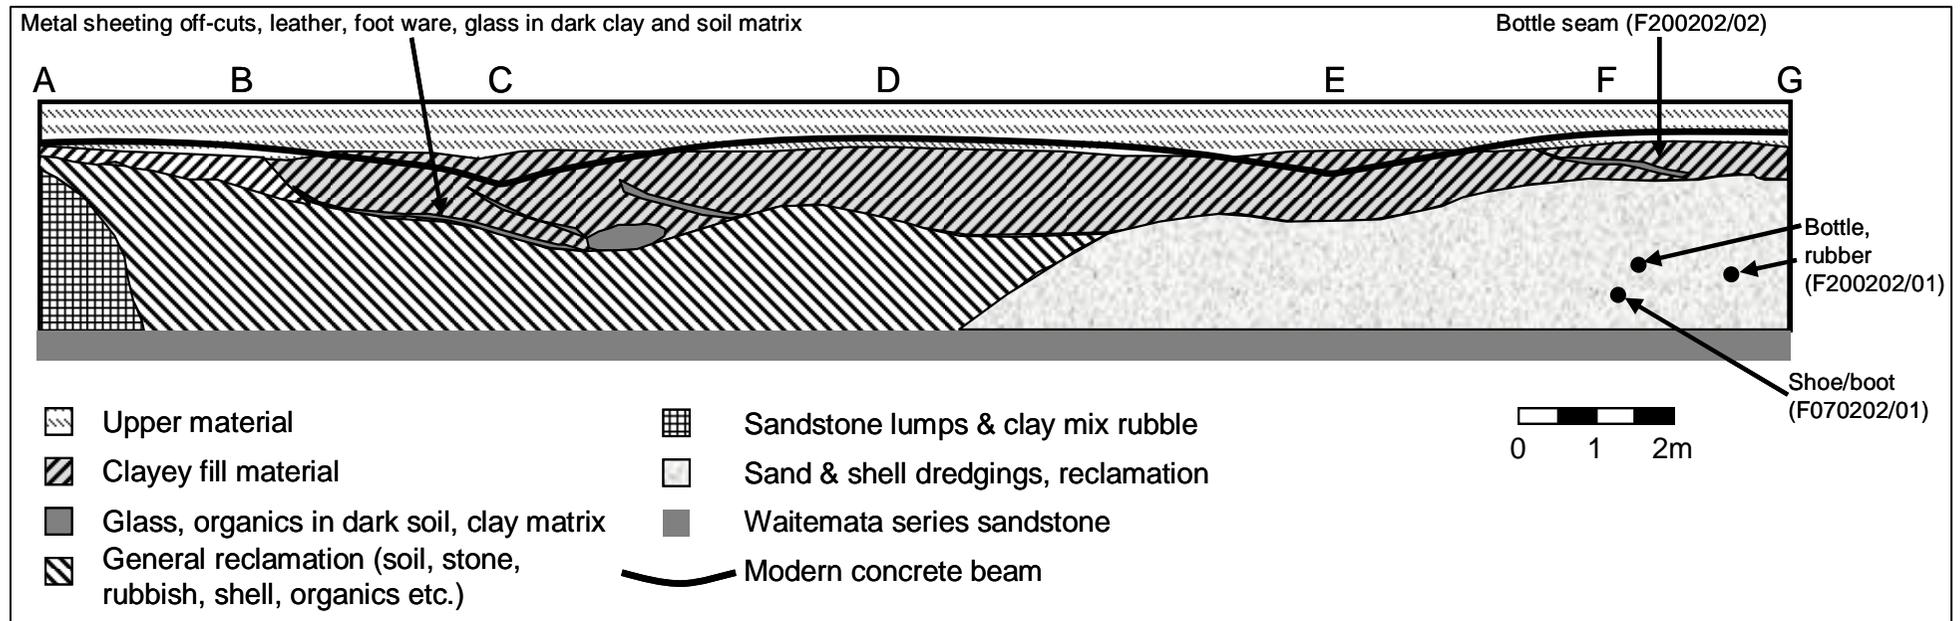
Figure 14. Simplified East Section Grids B-G, 18-19 (see Chapter 1 for description of grid locations)

Generally the top 2-3m consisted of commercial and domestic refuse, which followed a pattern of tip-head dumping (Figure 14). This was evident across the reclamation where concentrated dumping of similar materials were dispatched over the leading edge of the tip, thereby showing in cross-section as sloping lenses of deposit. These included concentrations of leather, bottles and glass, tin off-cuts, dumping of vegetation and wood (Figure 15). Many areas showed evidence of burning and in one case in the vicinity of the Gore St Jetty, an area of some 200m³ was so contaminated with chemicals that special excavating procedures and dumping locations had to be arranged.

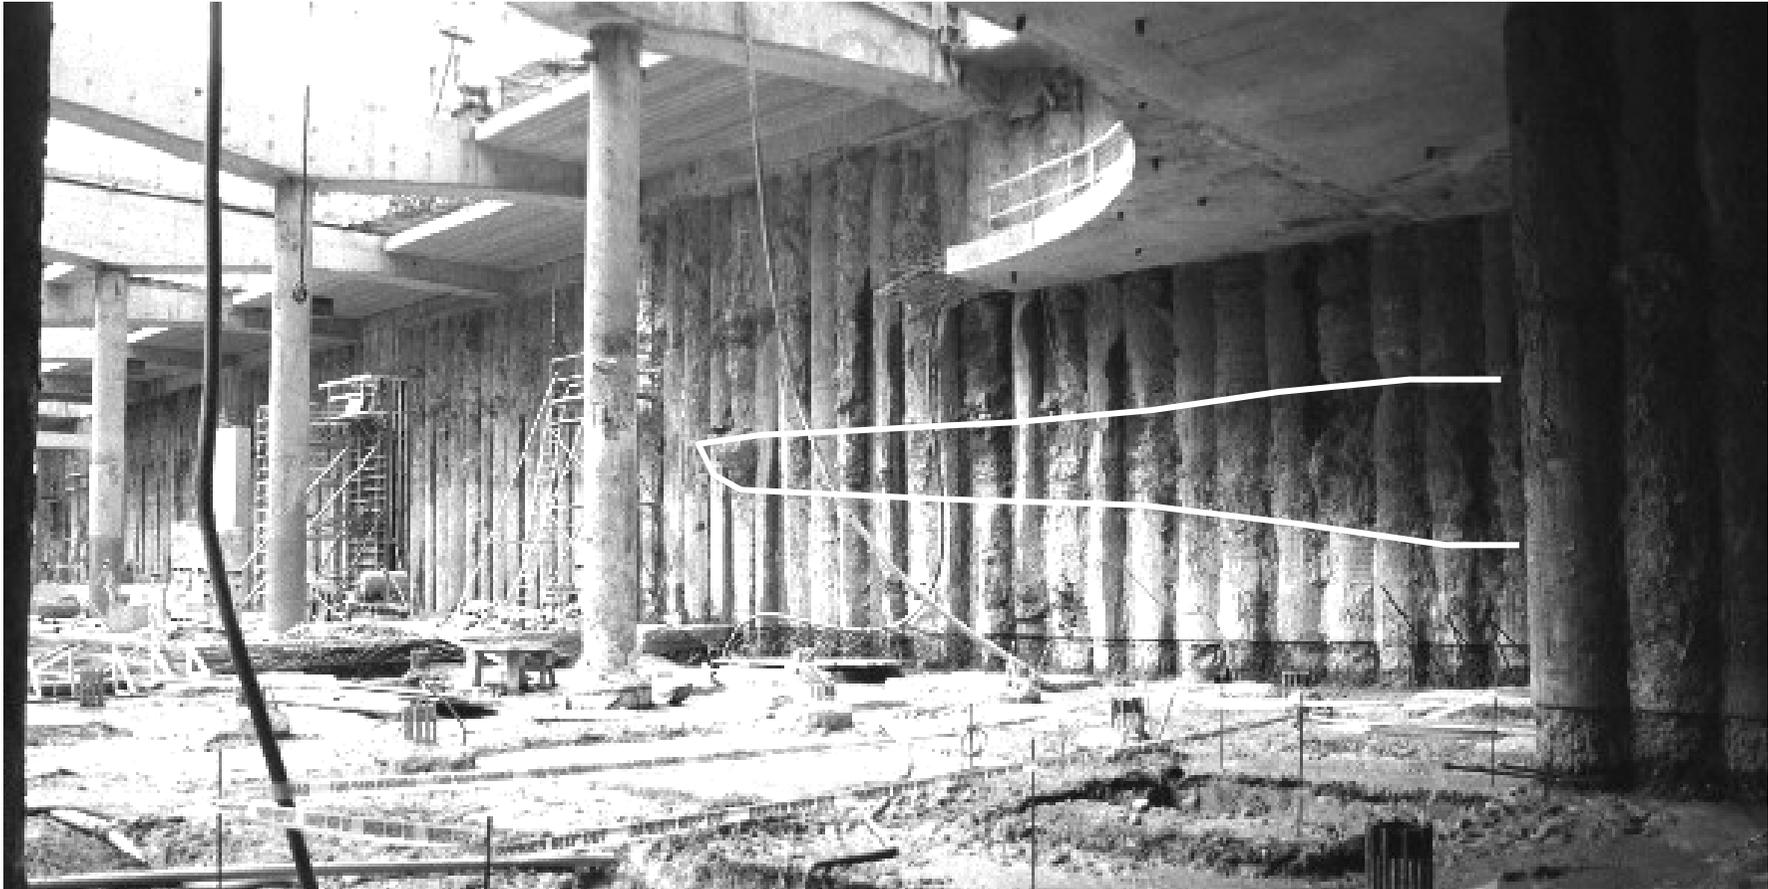
Figure 16. Stratigraphy of sea bed illustrating thickening of seabed muds

The seabed was shallower towards the east, and sloped downwards from east to west into the area of the old Waihorotiu Stream bed. Visual evidence for this was observed along the southern side of the excavation where the secant piling was installed. The secant piles were drilled through the upper layers of reclamation, through the mud of the seabed, and into the lower Waitemata Sandstone. In the vicinity of Grids 5 to 7 along the southern secant piling, it is possible to see the sloping stain line from the seabed muds (Figure 16), and its thickening as it closes in on the Waihorotiu Channel.

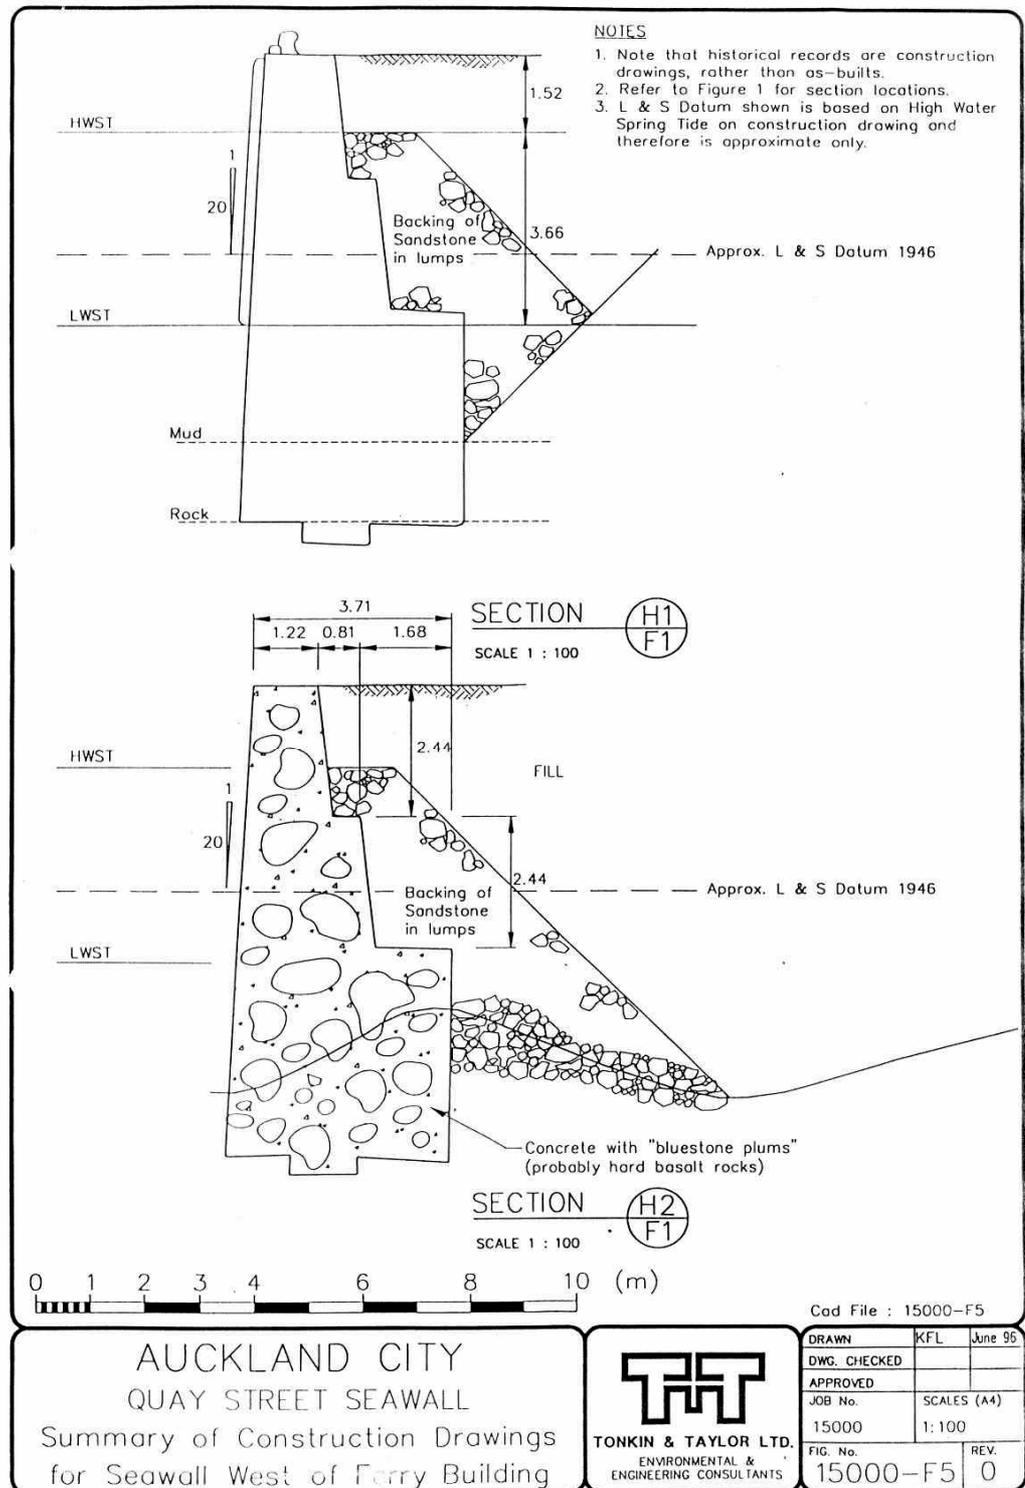
Figure 23.
Diagrammatic
representation of
Quay St seawall
construction

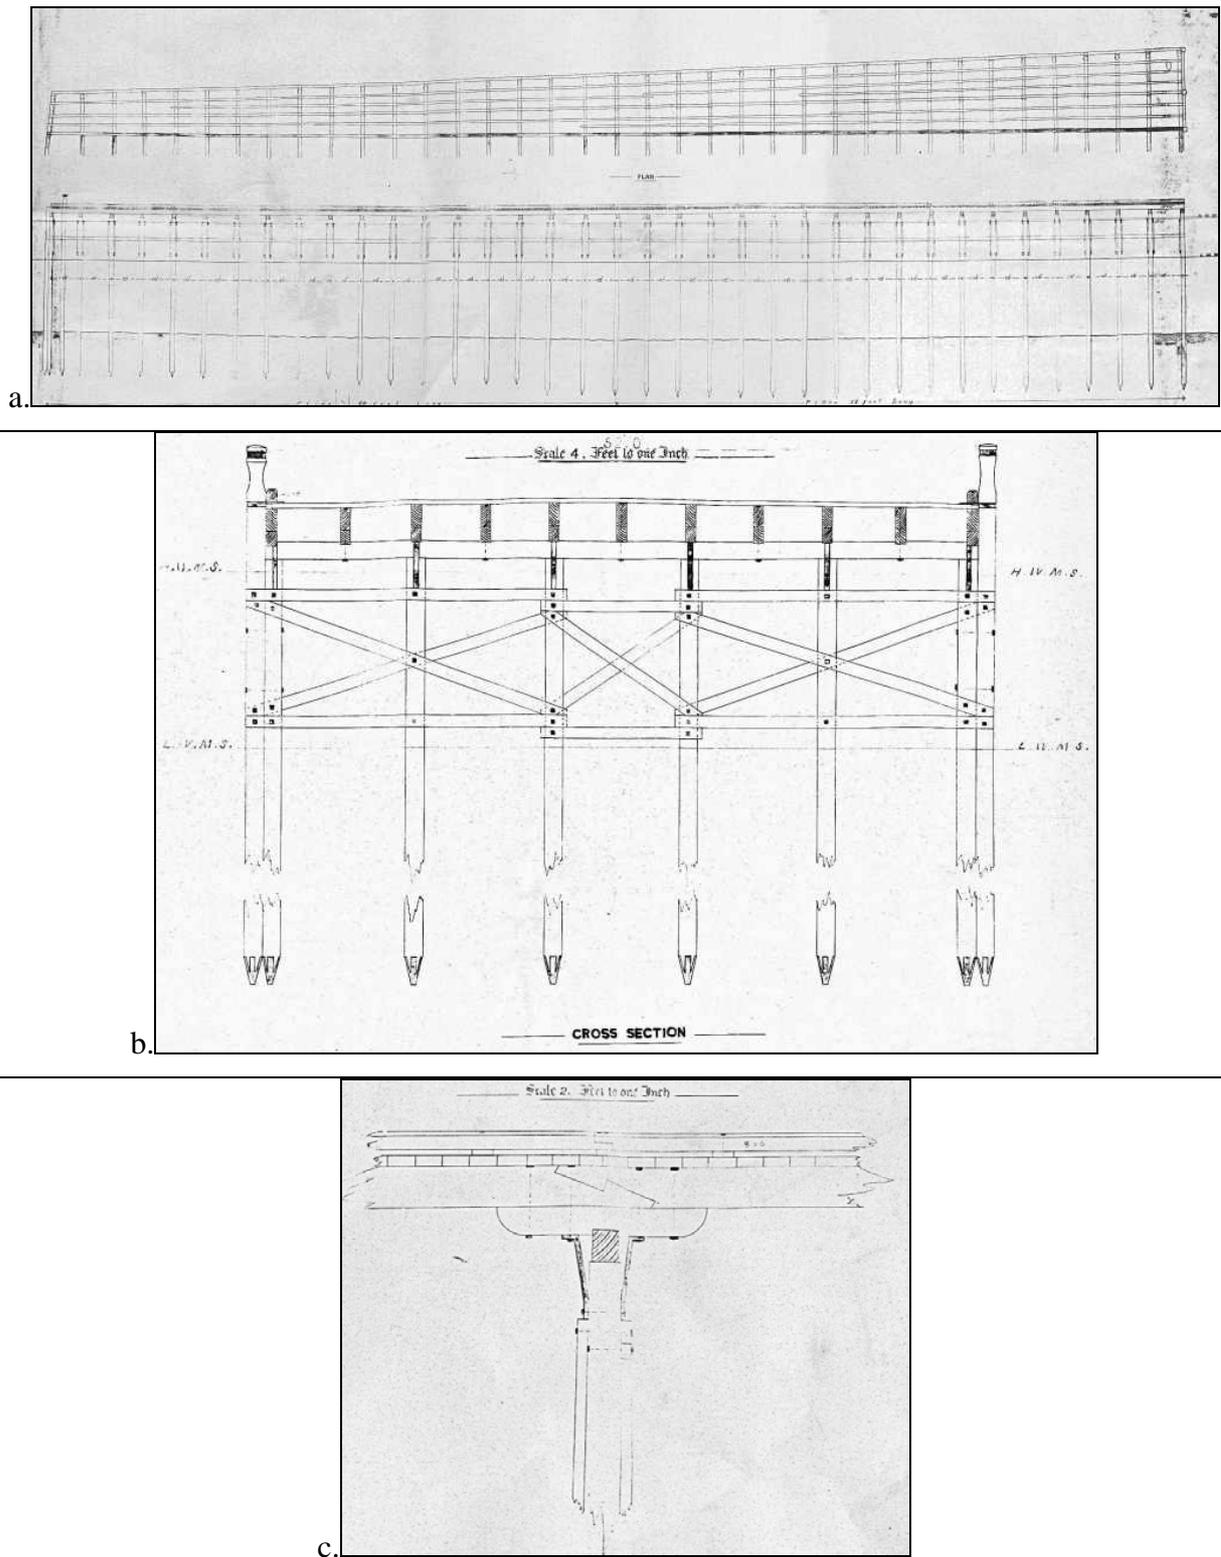
Figure 28. 1882 changes to Queen St wharf a) Extended decking to main northern tee; b) Cross section of new Tee 3 extension; c) Close-up of pile support for Tee 3 extension.

1882 Extensions The 1882 plans illustrate an increase in the size of the major tees and the addition of a western branch to tee 3. The engineering plans show the metal tipped piles similar to those recovered in the Gore St jetty excavations (see below). Tees 2 and 3 were widened to 30ft and lengthened to 150ft on each side. Tee 1 at the northern end was also broadened considerably Figure 28).

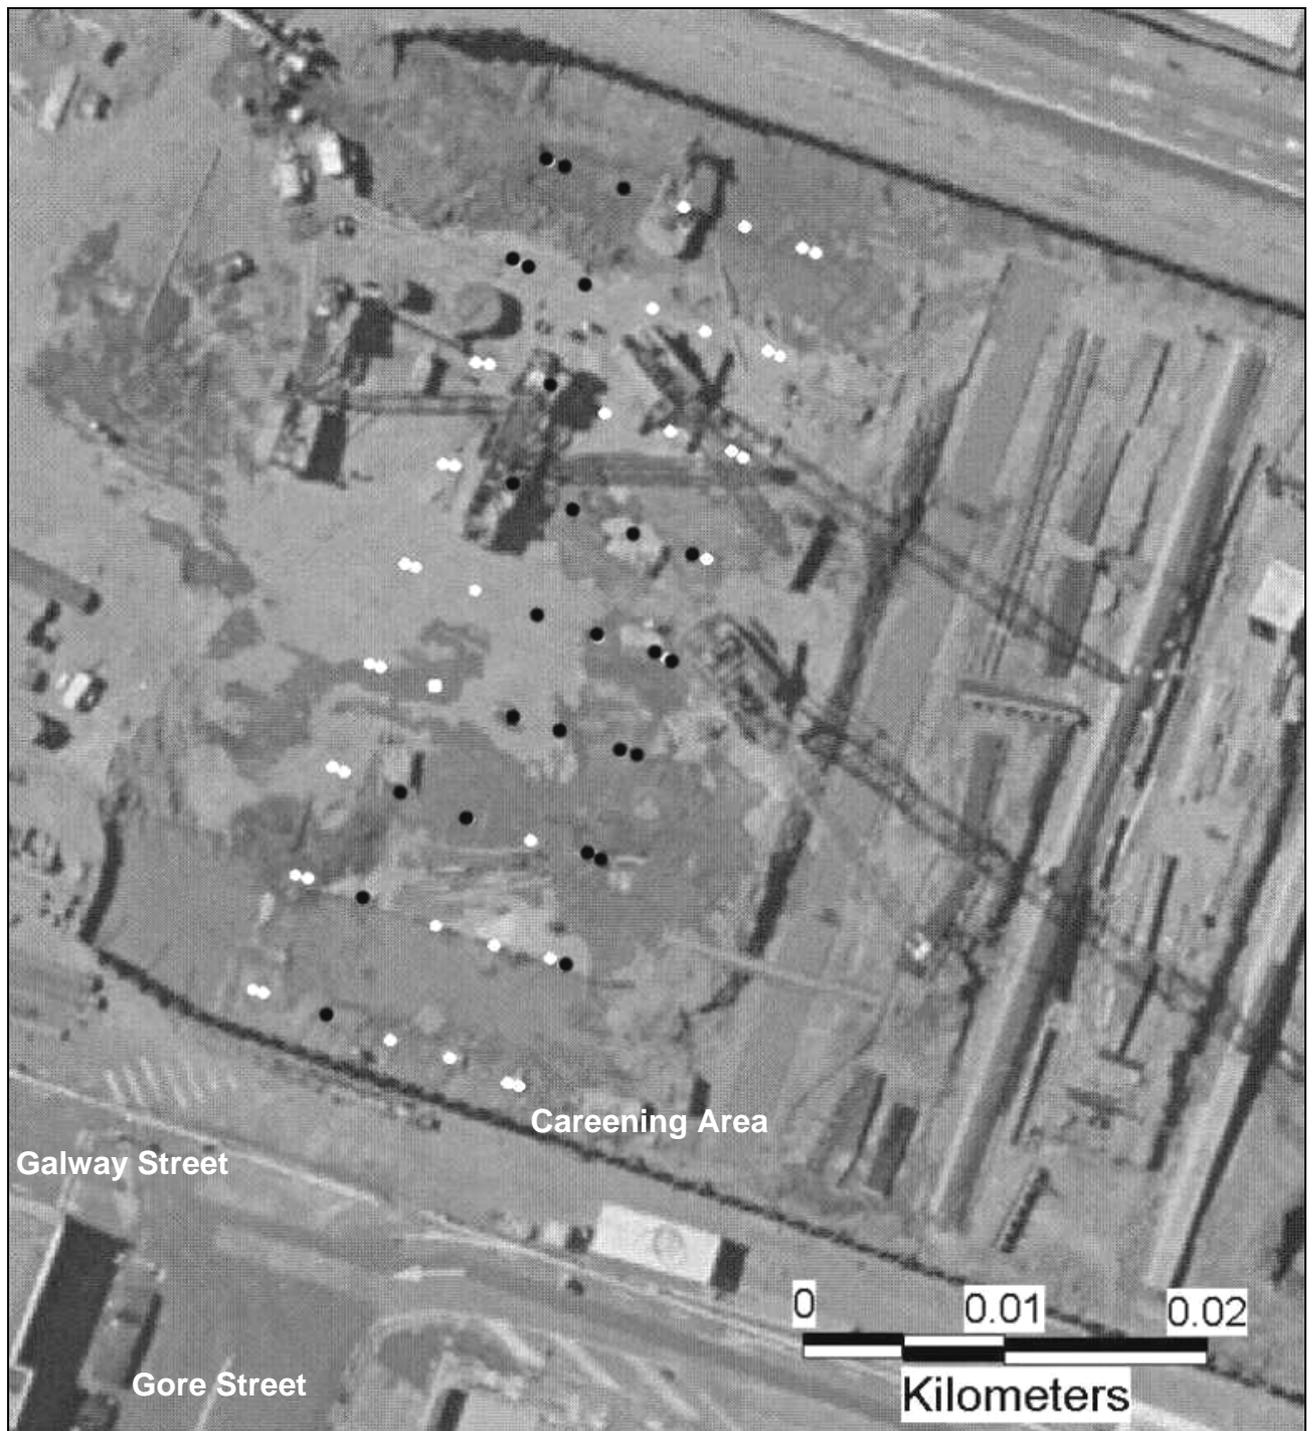
Figure 31. Plan of pile locations, Gore St jetty. Black dots indicate actual posts recovered, white dots indicate pile hole or projected location

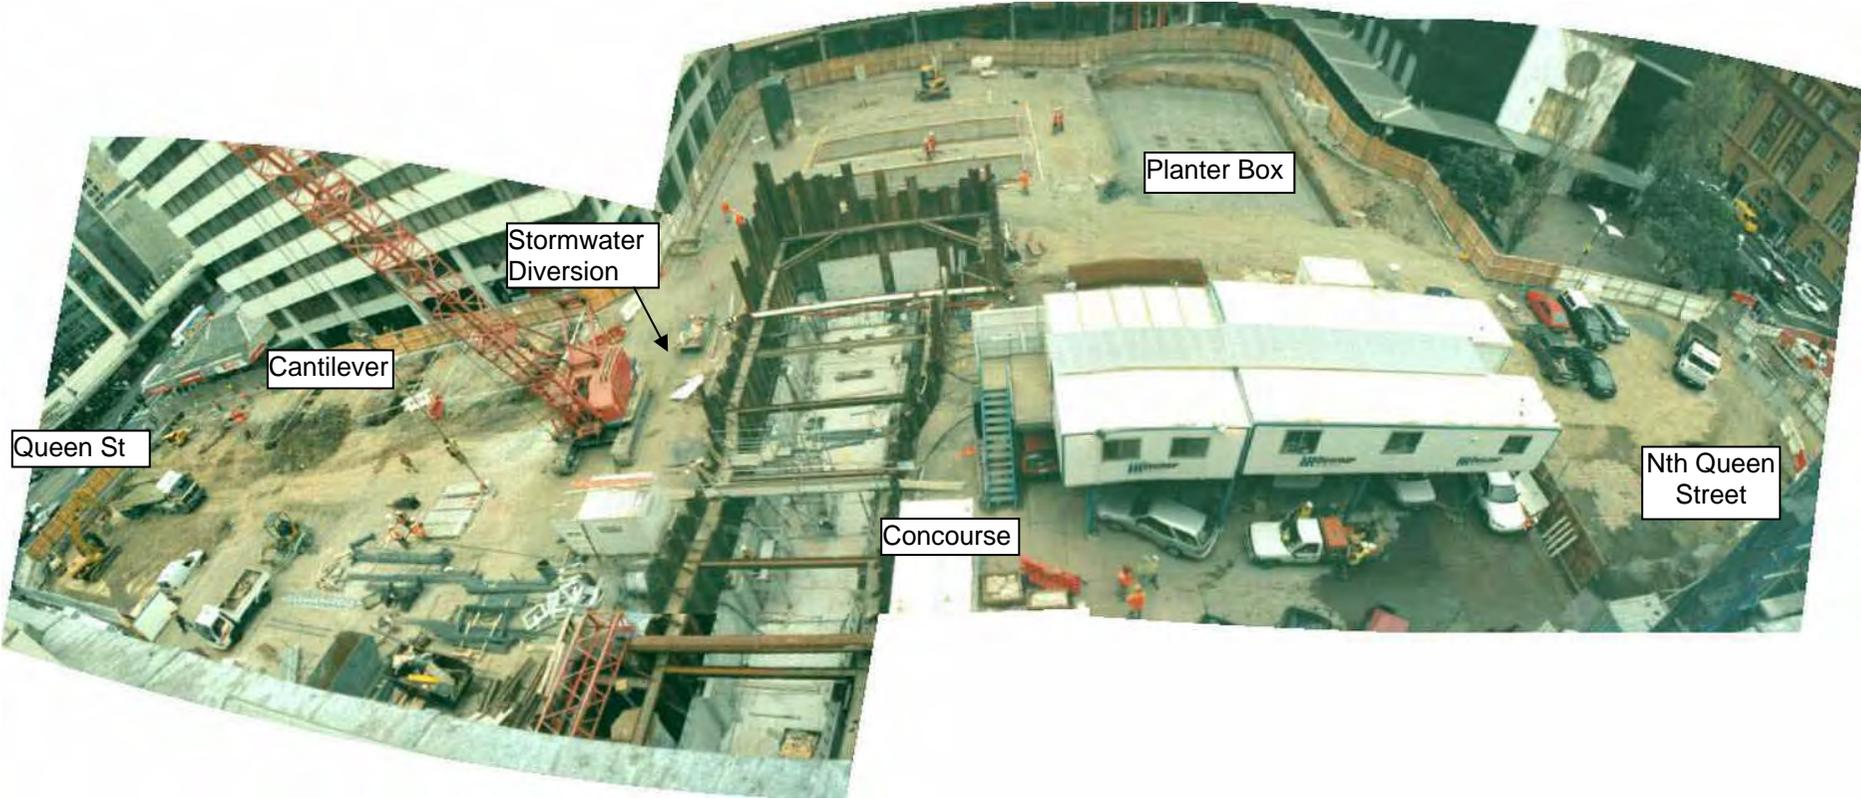
Figure 52. QEII Square Concourse Excavation; view of sheet piling installation

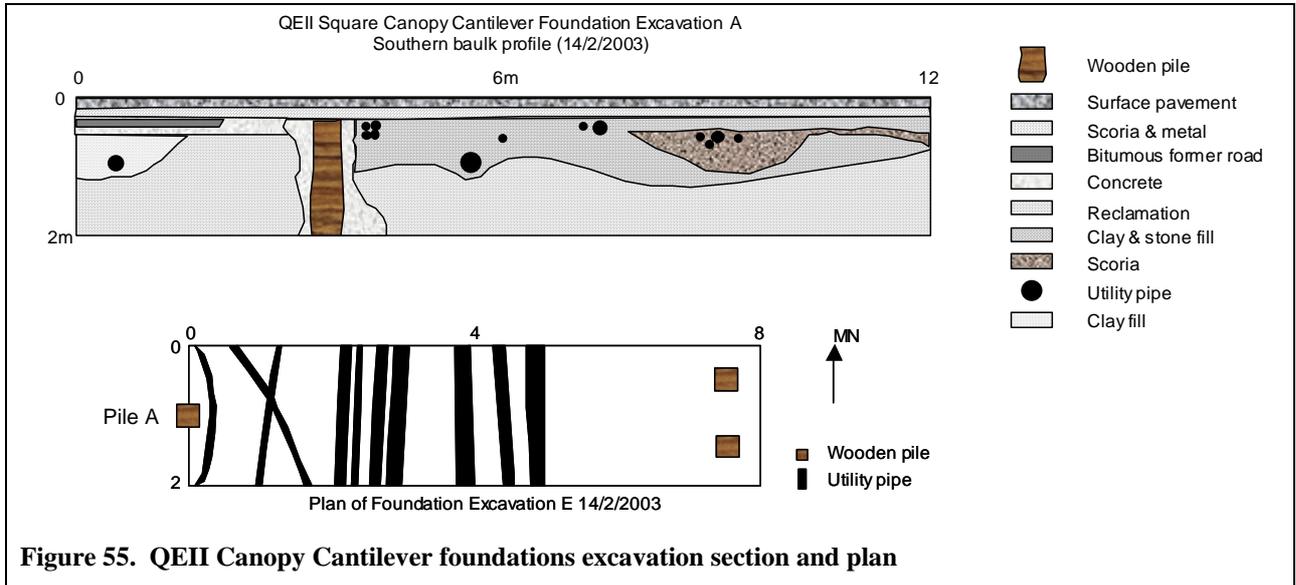
Figure 55. QEII Canopy Cantilever foundations excavation section and plan

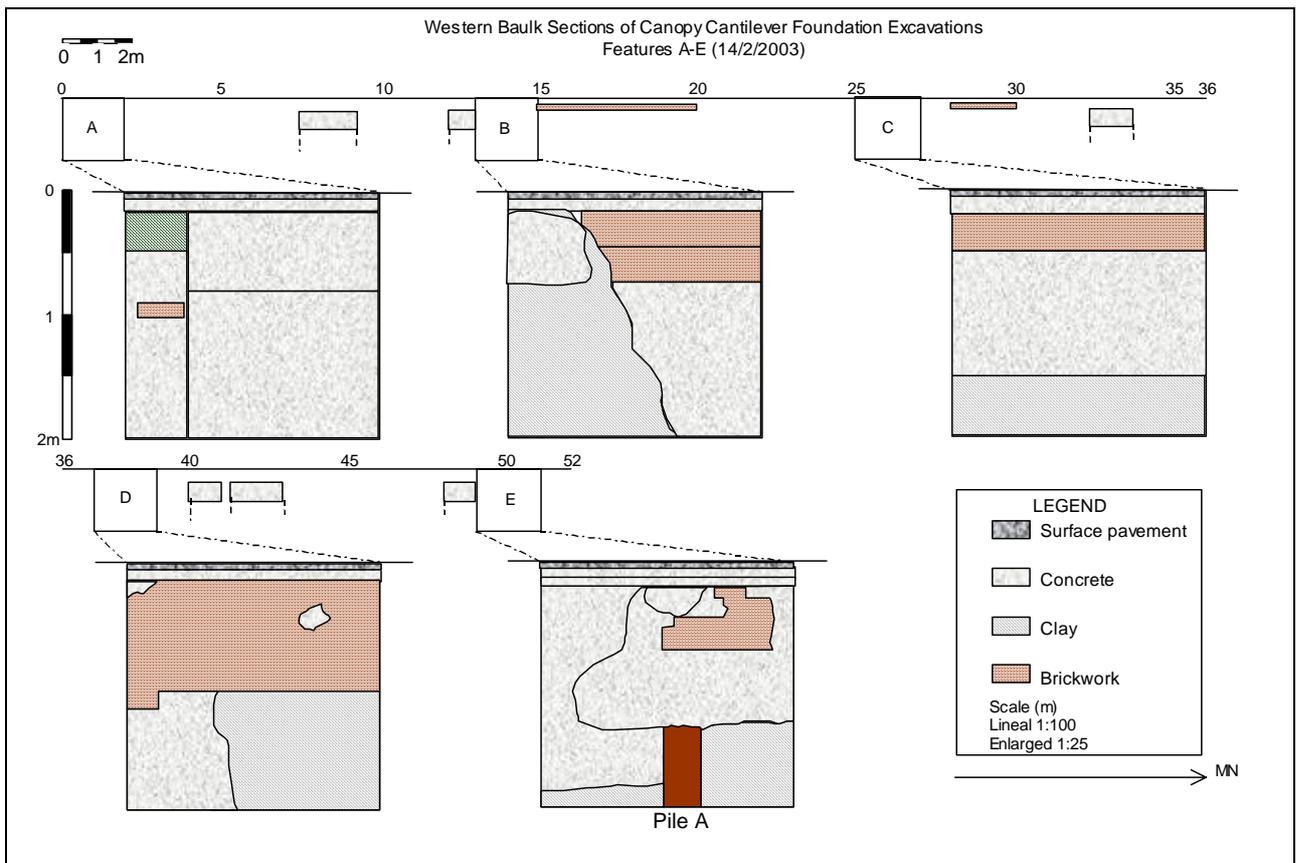
Figure 56. QEII Square - Cantilever Excavations. Western baulk sections (F140203/01)

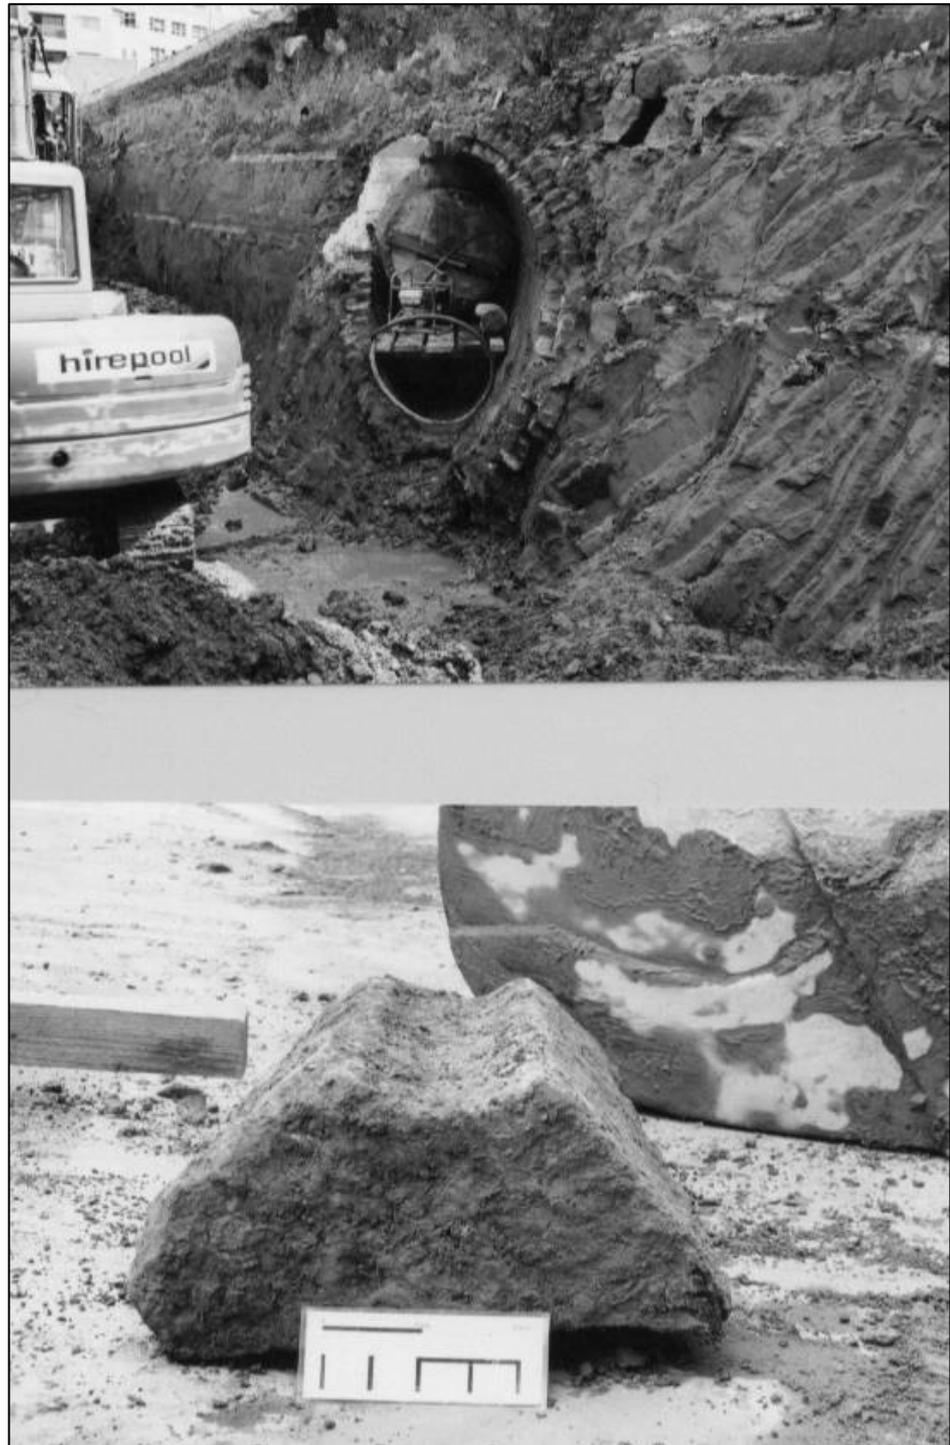
Figure 59. Brick culvert and keystone uncovered at Britomart Place

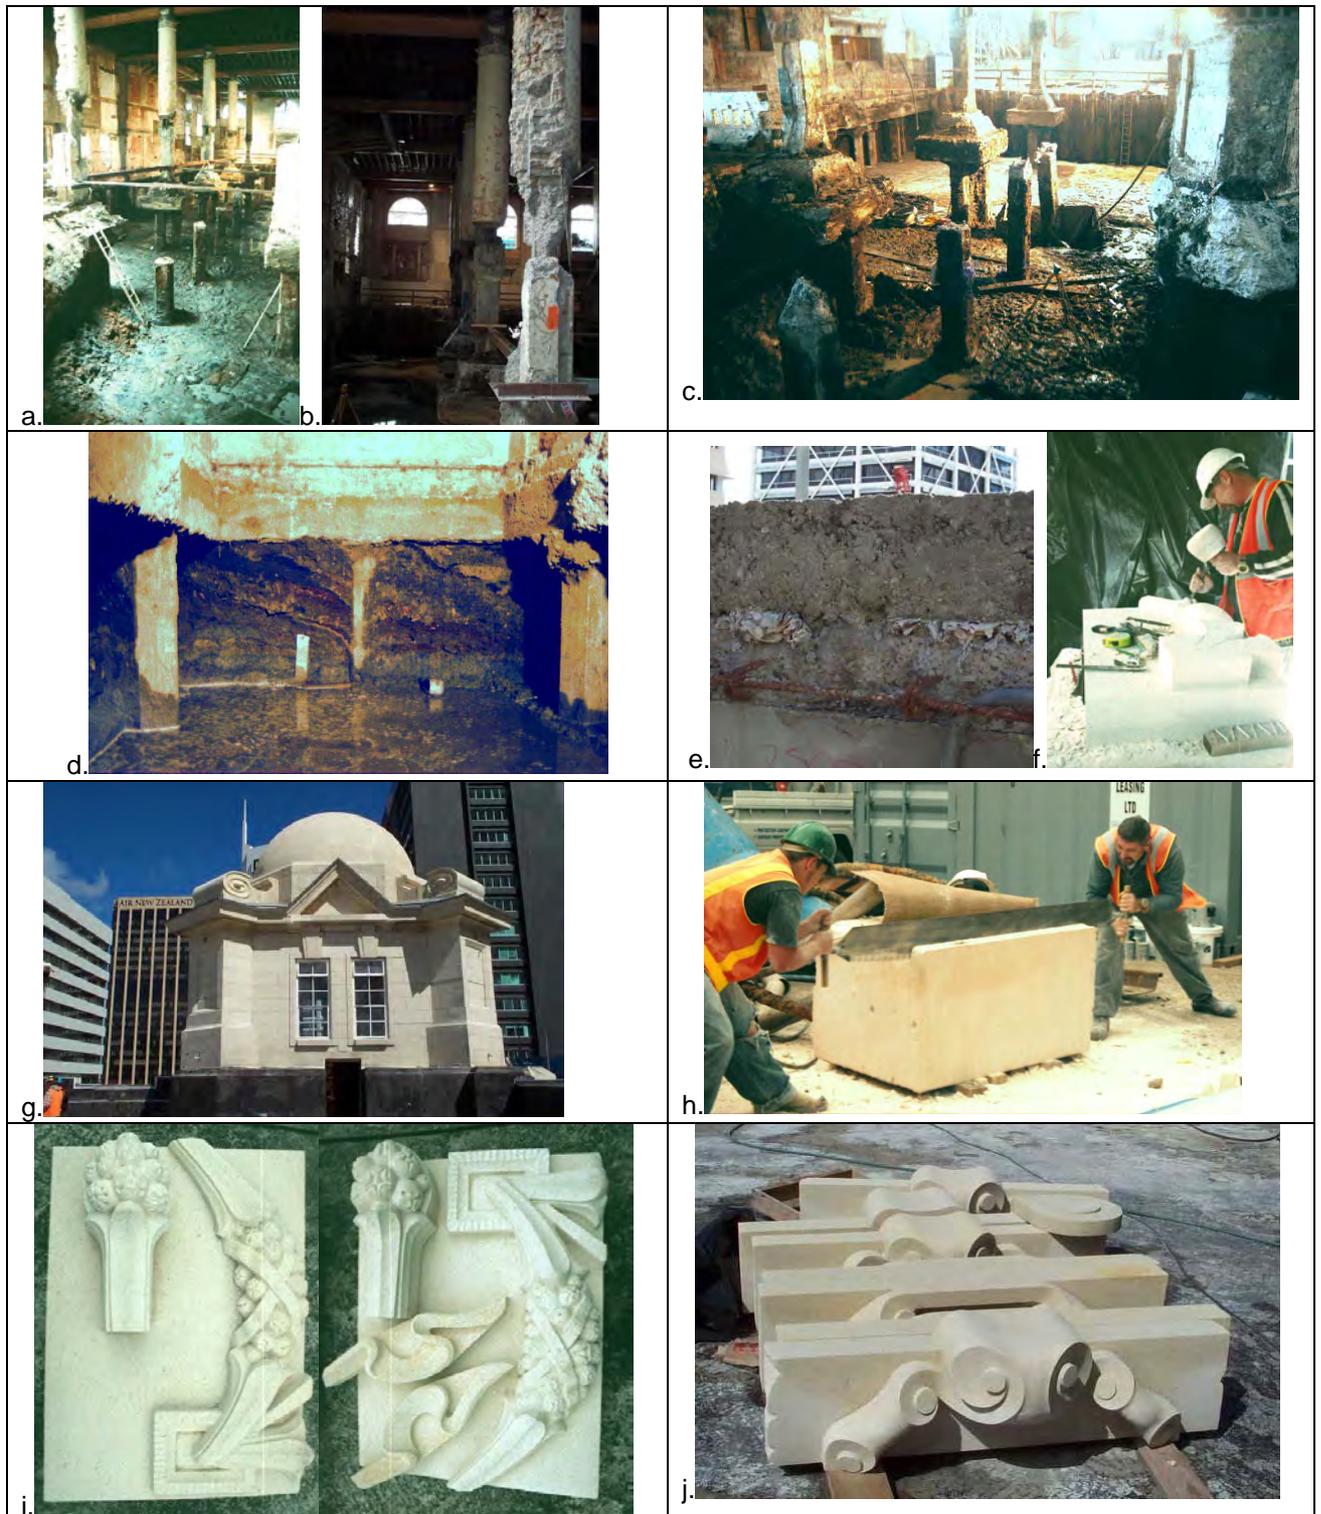
Figure 72. CPO Excavations: a-b. View internally showing pillars and area excavated; c. Area B - internal piles; site concrete poured; d. View W showing W baulk of internal excavation of CPO prior to breaking through into 'Concourse' outside; concrete columns to (L), (R), and centre; reclamation dumpings visible including scoria, tin, charcoal, clay, soil, ceramics, and mud; e. Concrete attachment on roof of CPO; f. Stonemason Jerry Smith; g. Roof of CPO; h-j. Oamaru limestone for facing – stonemason Jerry Smith

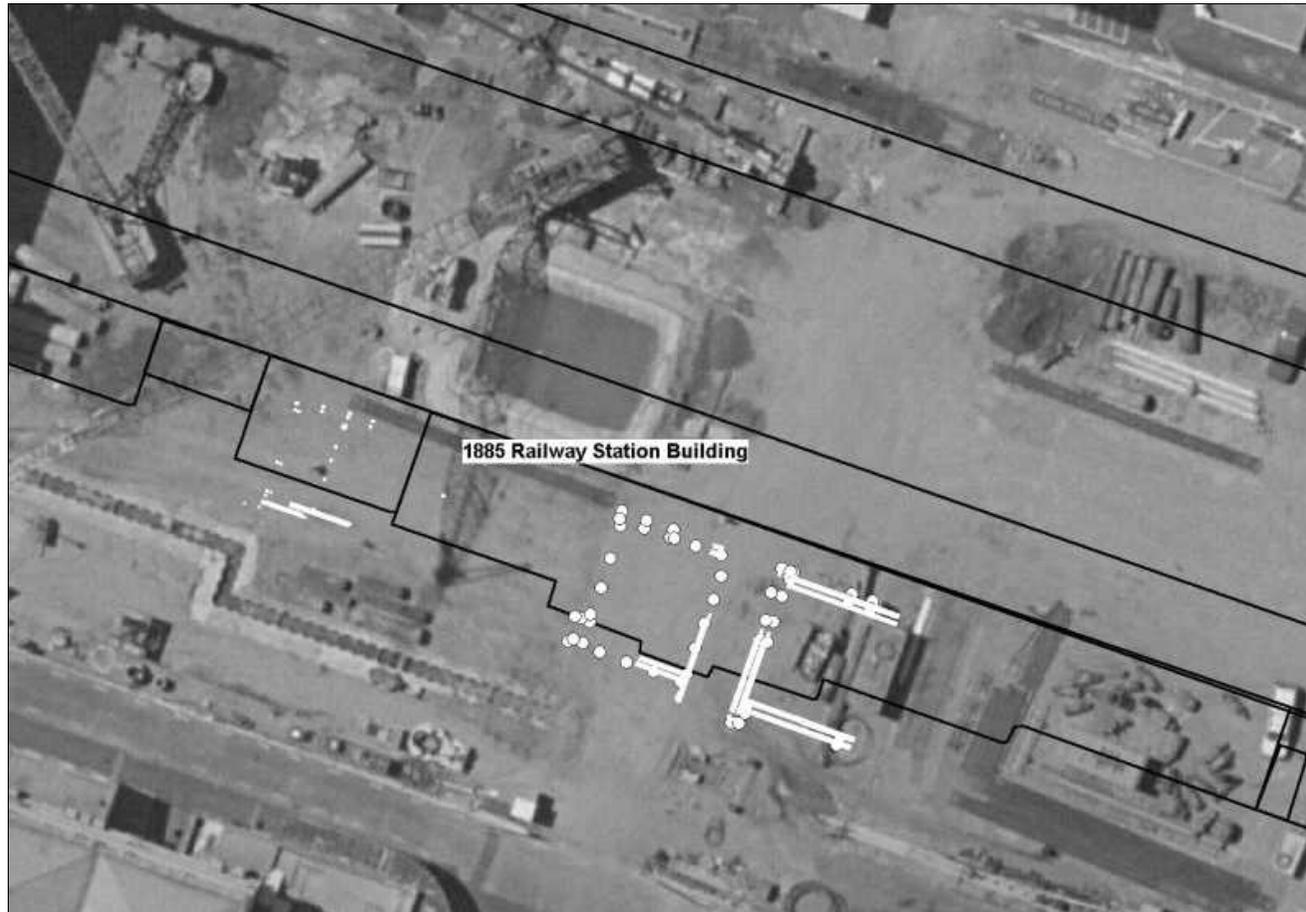
Figure 87. Excavation of railway piles and beams. Aerial photo (2000), location of original station building and platform (1908), excavated piles and beams (in blue and black)

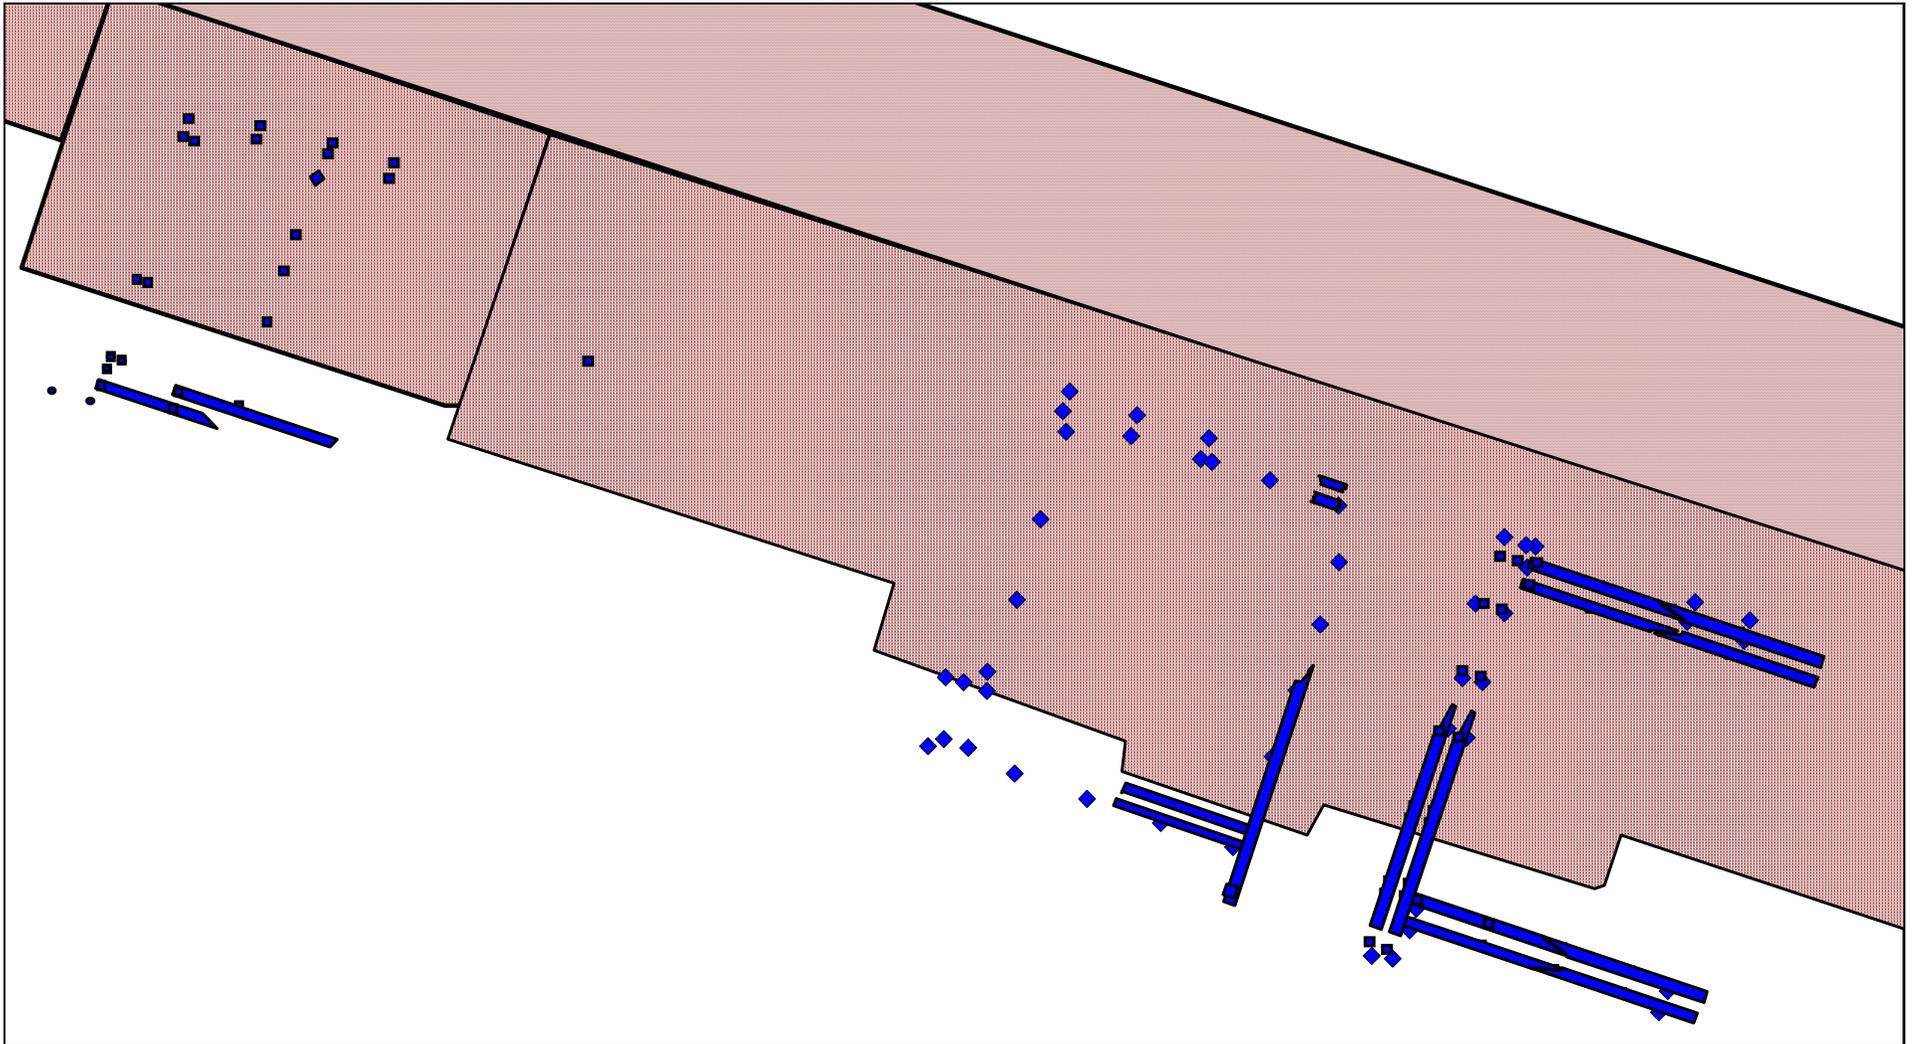
Figure 88. Close-up of piles and beams excavated from the Railway Station building
