Excavations at

Britomart

Auckland (R11/1379)

Site Report for Auckland City Council
2005

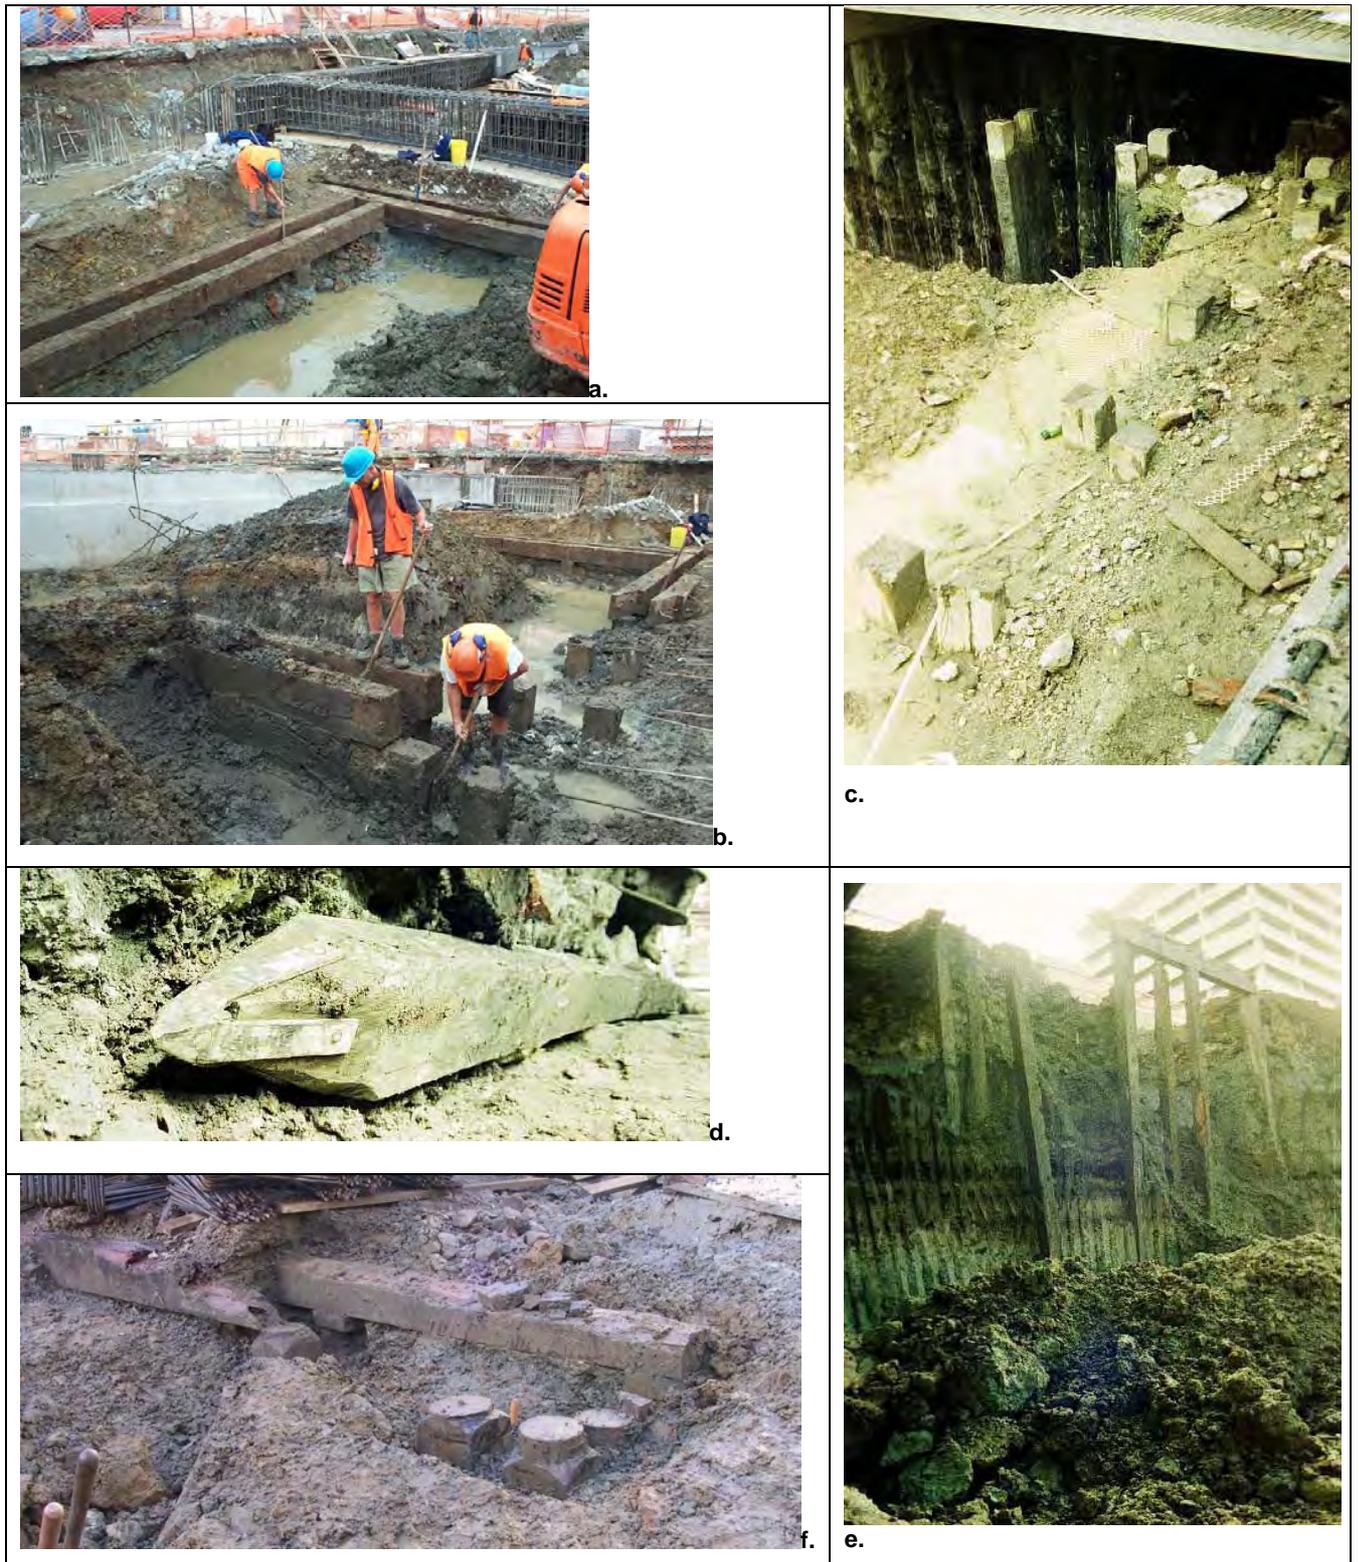
Figure 89. Images of the excavation of the Railway Station building: a and b) Double beams probably under the ‘tower’ area; c) GA-C09, piles and beams; secant piling in rear from G9; d) Forged metal driving point on pile from Railway substructure, Grid 10 A-C; e) Grid A-C9 – beam on piles driven into bedrock; f) Railway Station bearers

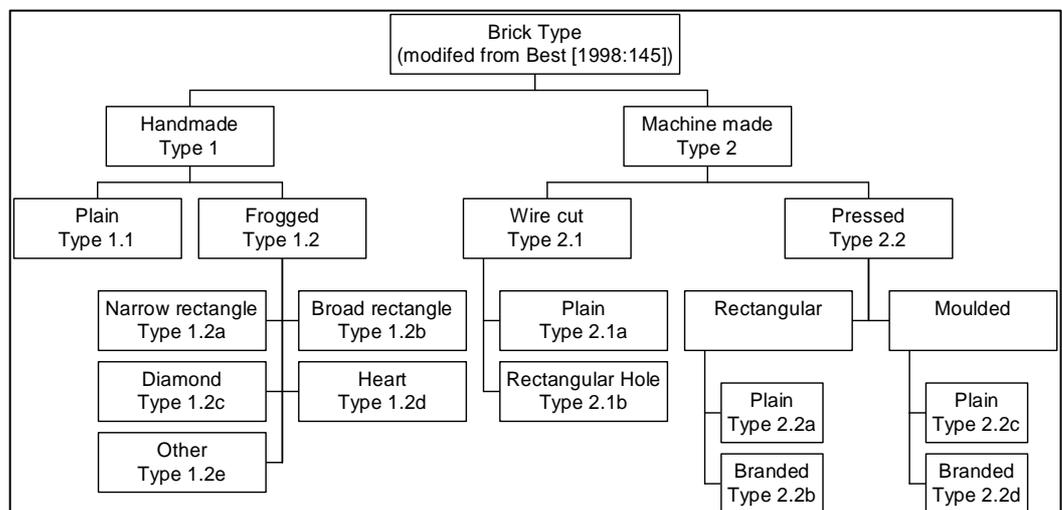
Figure 97.
Classification of
historic bricks
according to
manufacturing
method

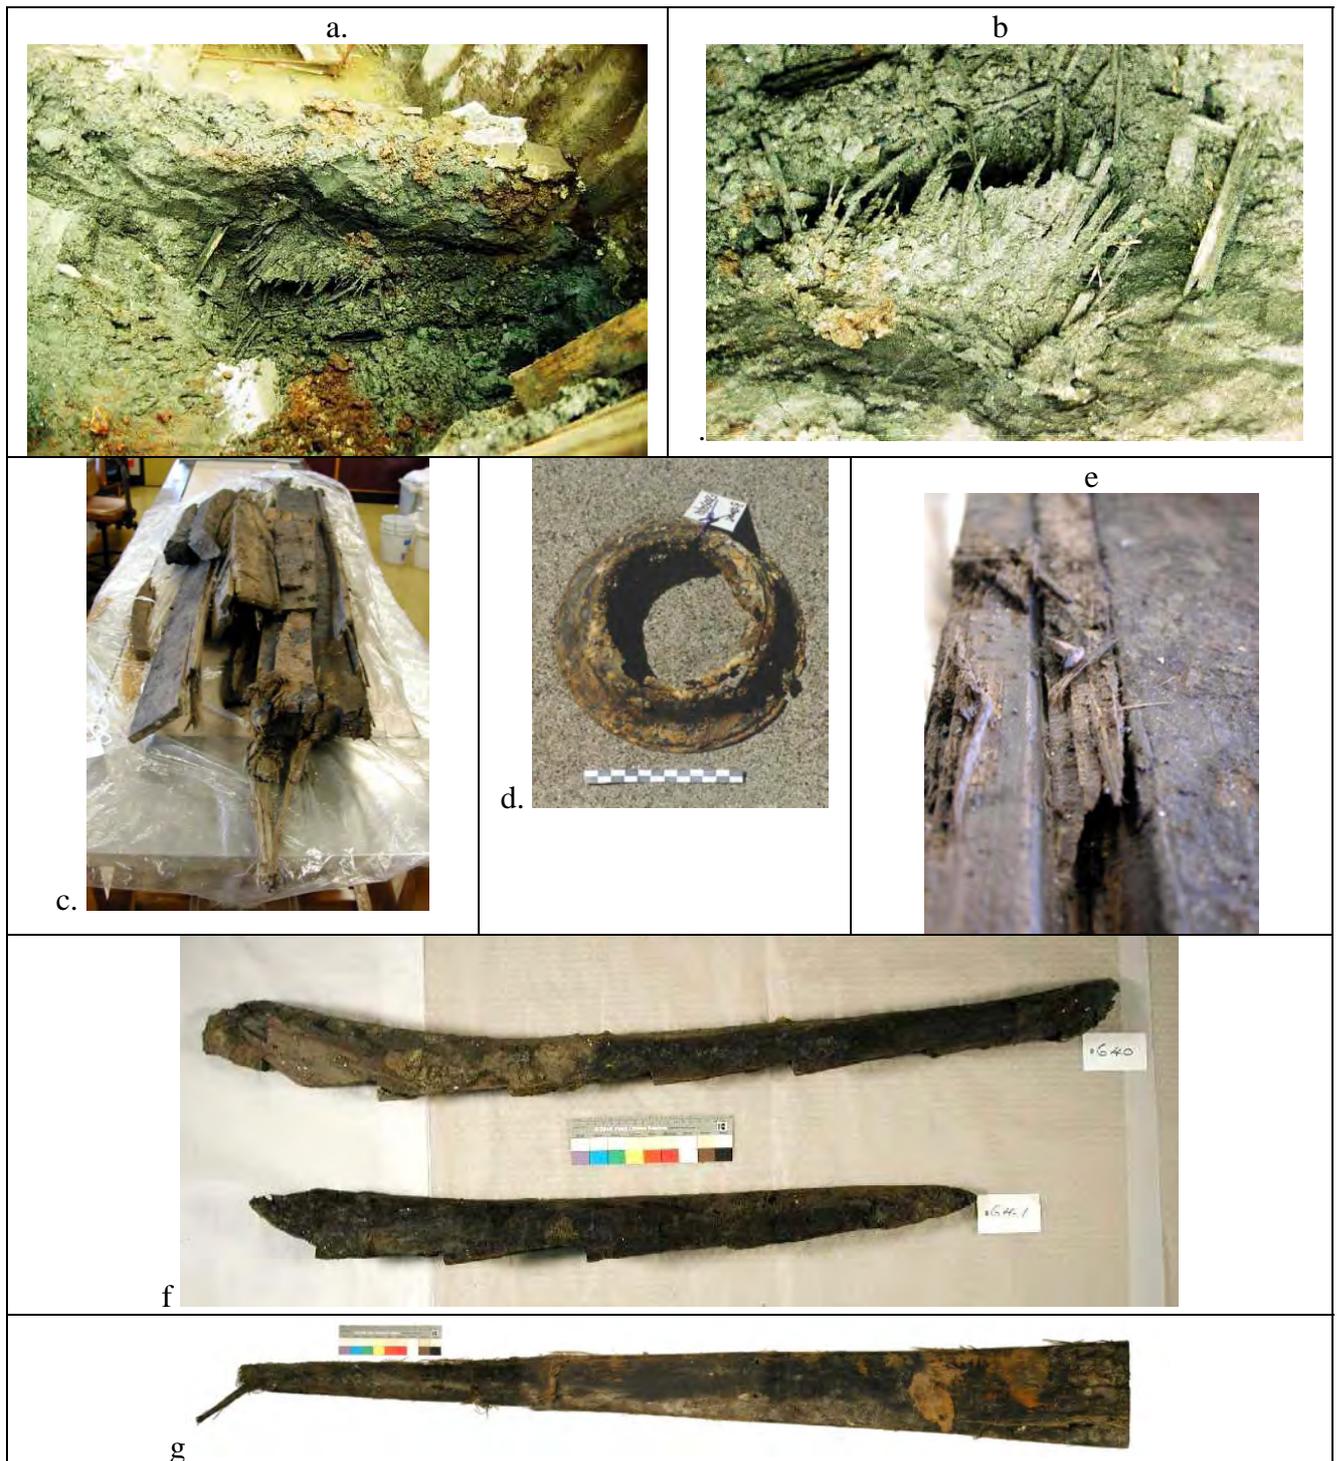
Figure 107. Harbour boat remains: a. F200502/02, remains of small boat; b. Close-up of remains in situ; c. Skirt-like circular object; diam at top = 115mm; d. Recovered planks in lab; e) Close-up of ridging for planks to be inserted into keel; f) Ribs; g) Shaped planking

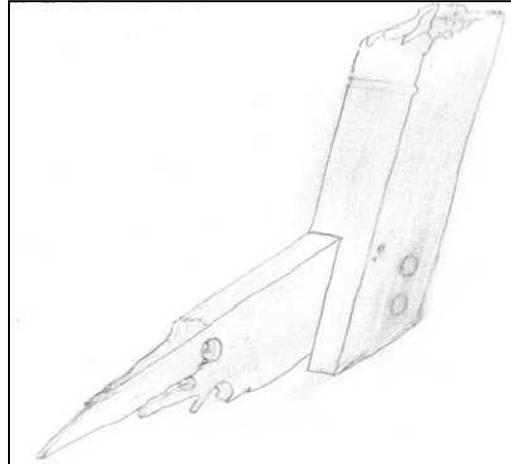
Figure 108. Showing remains of hole from fixing element 140mm long and 12mm in diameter. Also visible is the rebate [top right], which housed the garboard strake

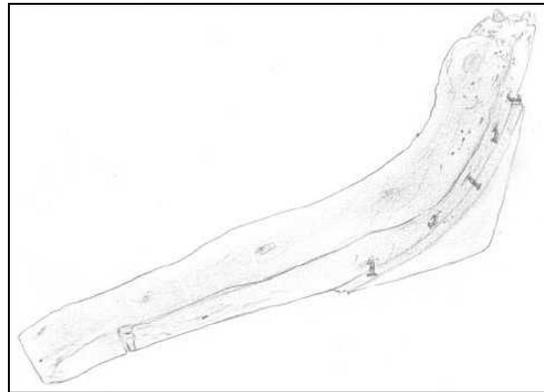
Figure 109. Sternpost attached to broken part of keel

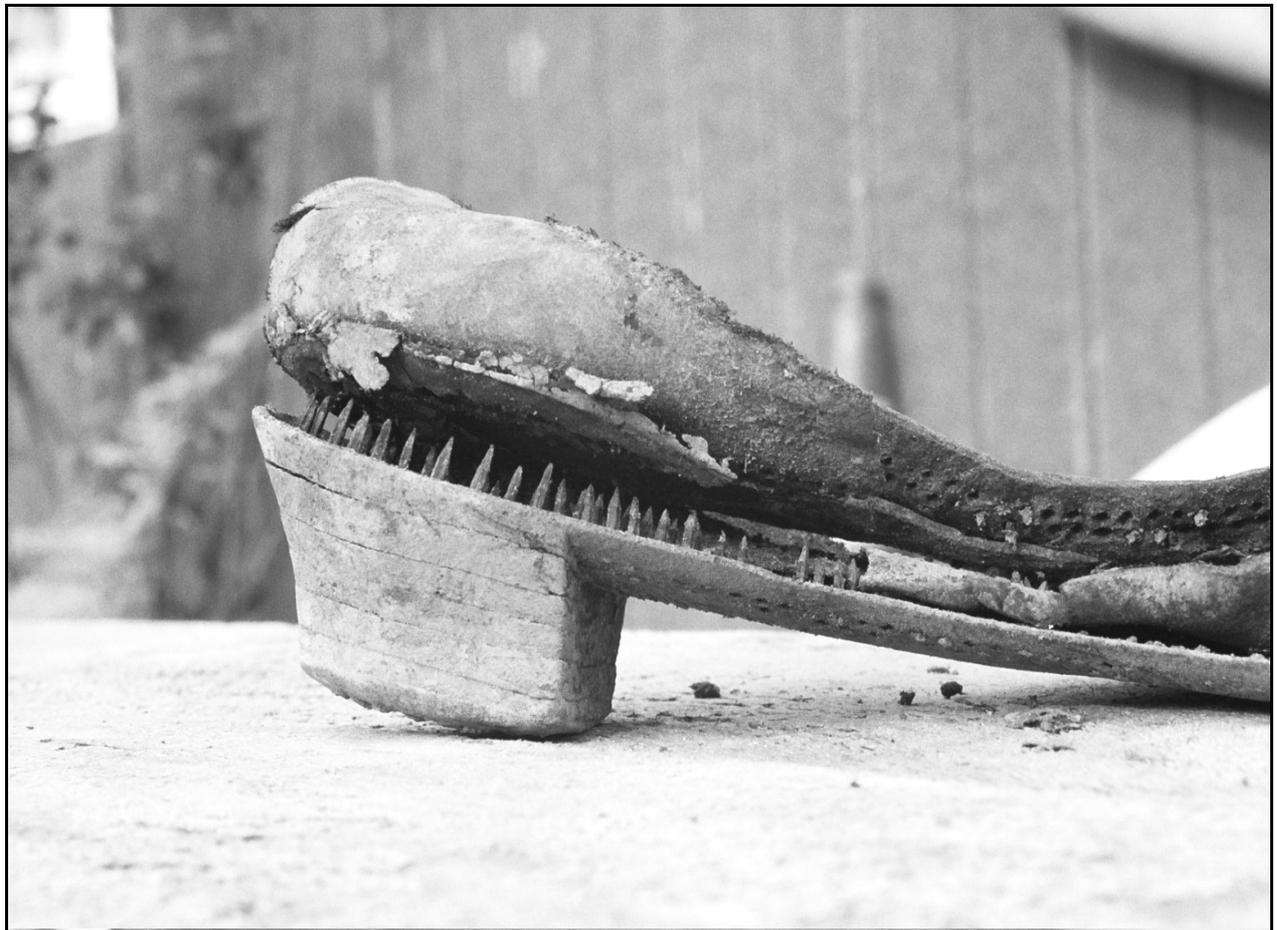
Figure 145. Wooden pegs holding sole and heel to upper of elastic-sided boot
