Doing Time at the Mount: Archaeological Investigations at Mt Eden Prison

Final report for NZHPT Authority
2008/144

Prepared for
Department of Corrections

October 2011

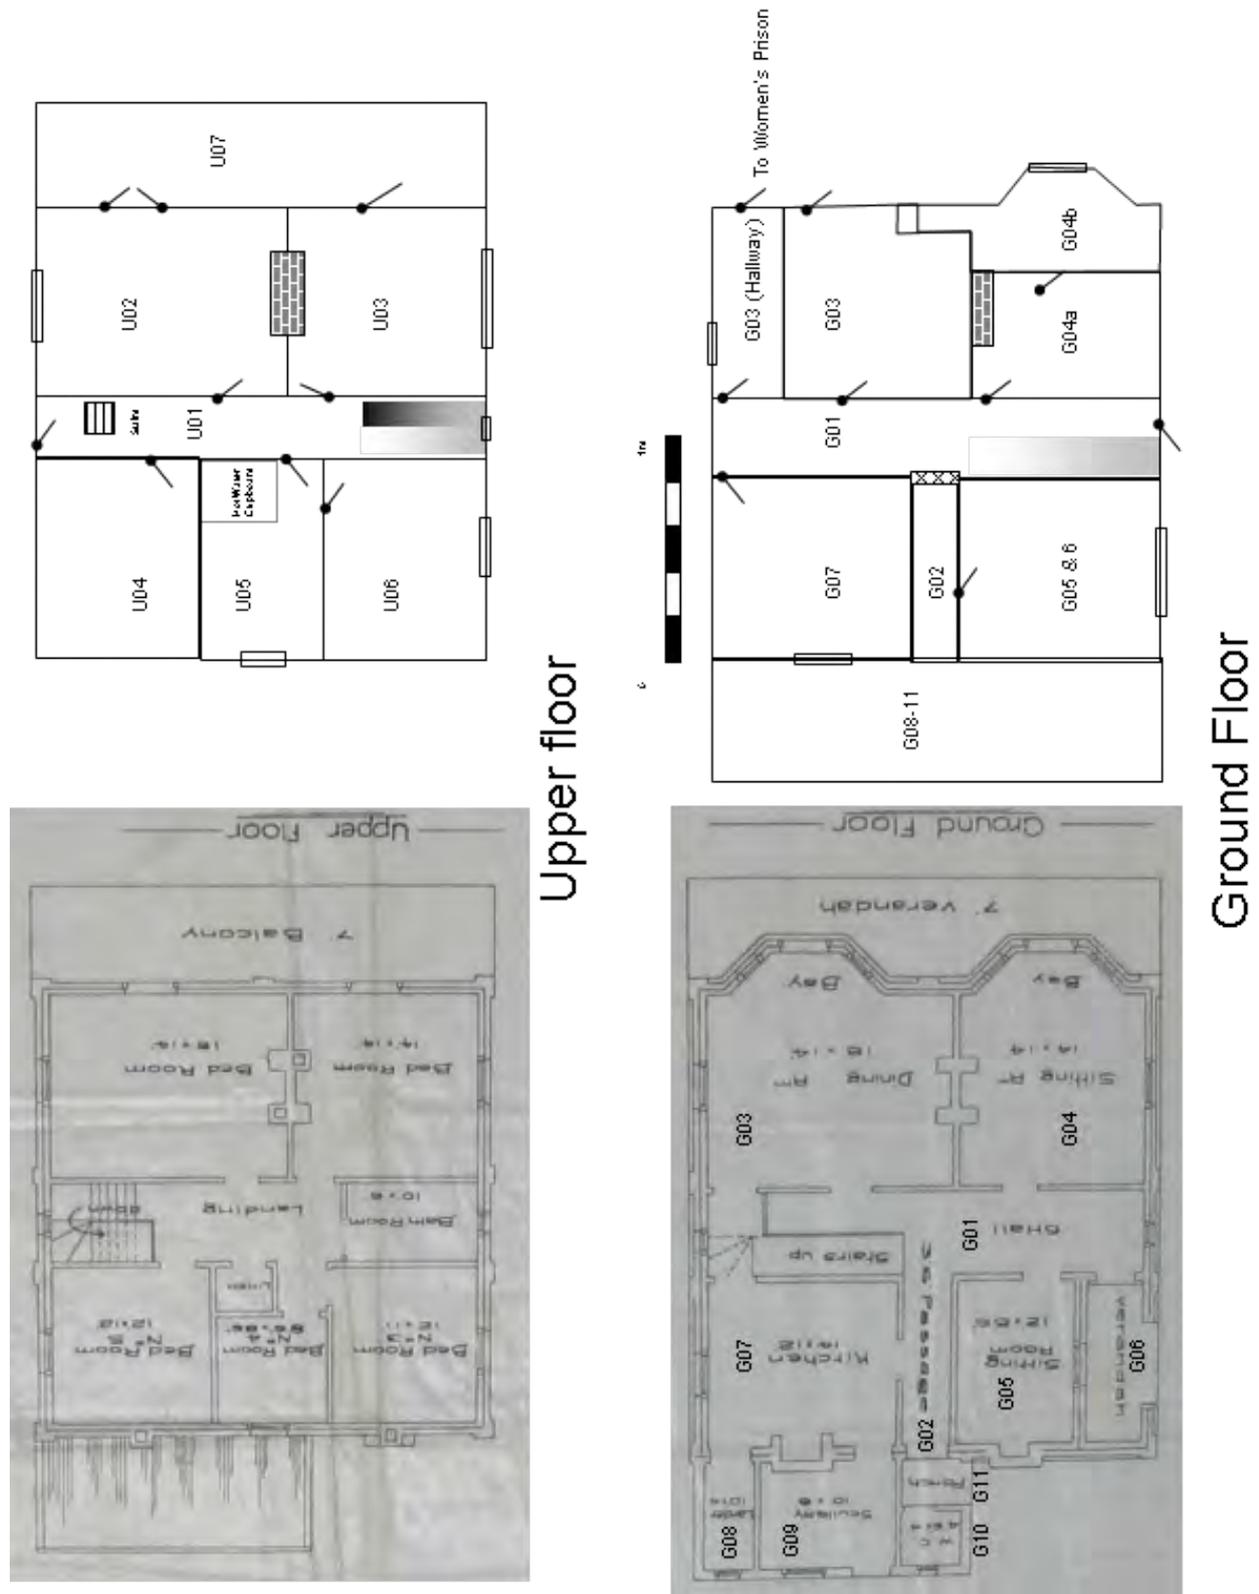
Figure 102. Floor plan of Superintendent's House (left: as shown in 1902 plan; right: as recorded in 2008)

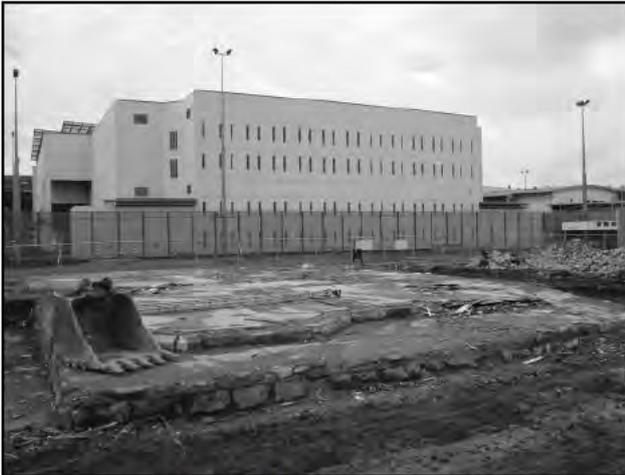
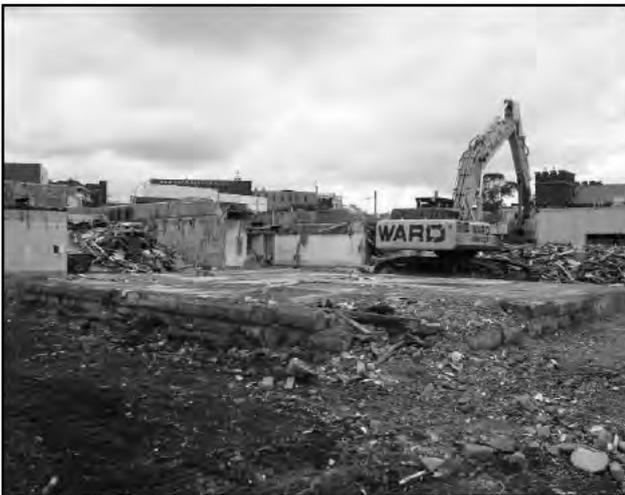
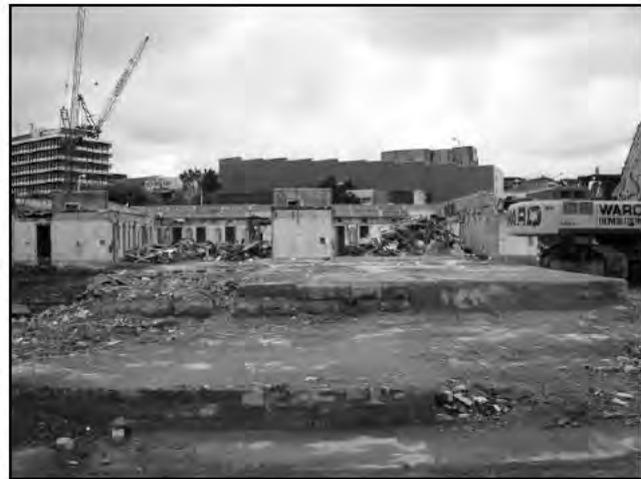
Figure 103. Foundations of the Superintendent's House

Foundations looking SSW

Foundations looking SE

Foundations looking NE

Foundations looking N

The exposed foundations of the house revealed that basalt blocks had been used as foundation materials (Figure 103). The blocks were used to provide a large level platform (Figure 103) for the building with a higher inner platform created around the main part of the house. In the south-west corner, this had been modified when the house was converted to a Women's Prison and the basalt foundations removed and replaced with a concrete pad (Figure 103, top right). The ground floor of the house was concreted, although this is also probably related to the conversion to a prison (Figure 104). It was noted that prior to demolition this floor was covered in modern linoleum. Removal of the concrete floor revealed the wooden framing for the floor (Figure 104–Figure 110). Plywood over the framing provided a flat surface for the concrete. This plywood was held up by the wooden framing that was mounted on floor joists. These in turn were held in place with the brick foundation walls and the basalt boulders used as piles (Figure 105).

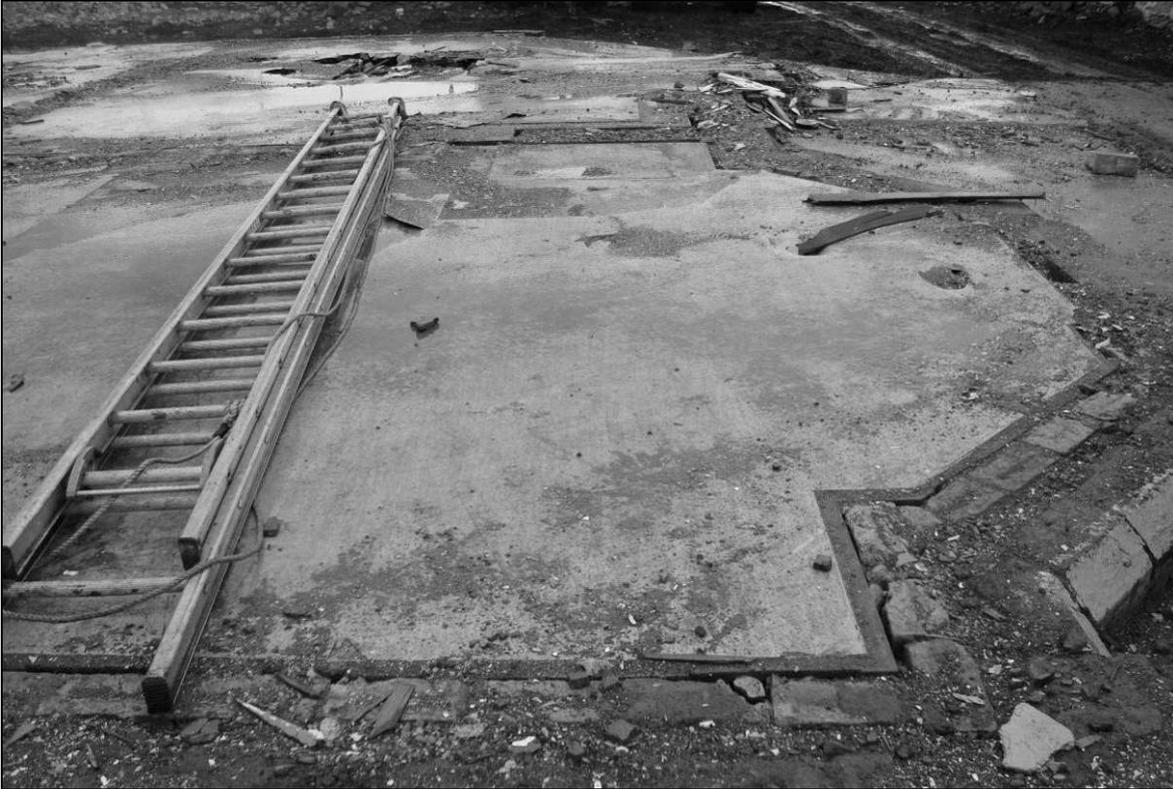
Figure 104. View of concrete floor of Superintendent's House

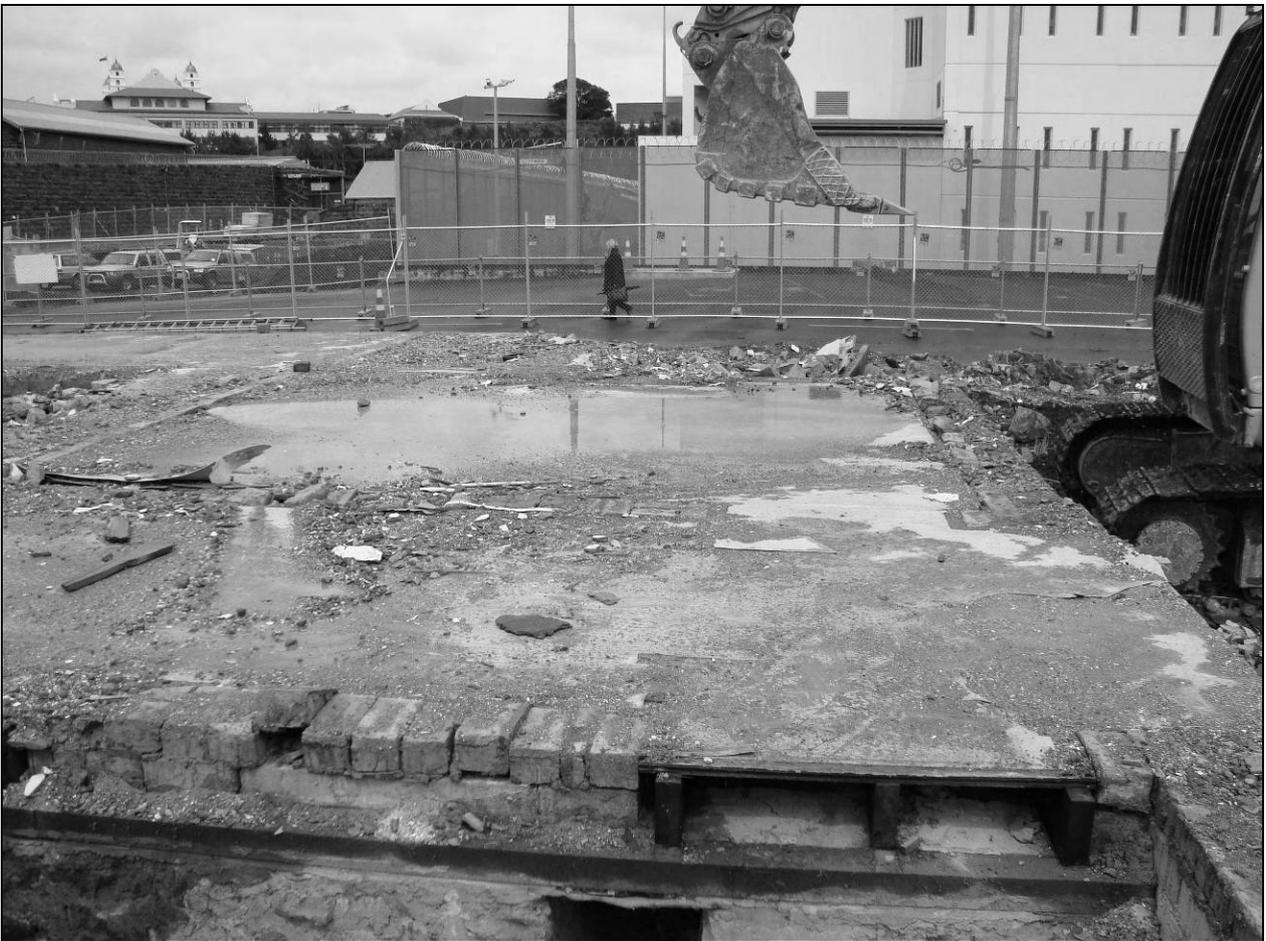
Figure 108. Metal beams in foundations of the Superintendent's House

The demolition also exposed other aspects of the foundations. The main construction of the foundation wall was the partially dressed basalt blocks (Figure 106). Concrete was added to doorways to improve some of the entrances and metal beams had been added in other areas to improve the strength of the foundations (Figure 108). Figure 109–Figure 111 show the wooden flooring on the foundations and a close-up showing the circular saw marks on the floor beams (Figure 112).

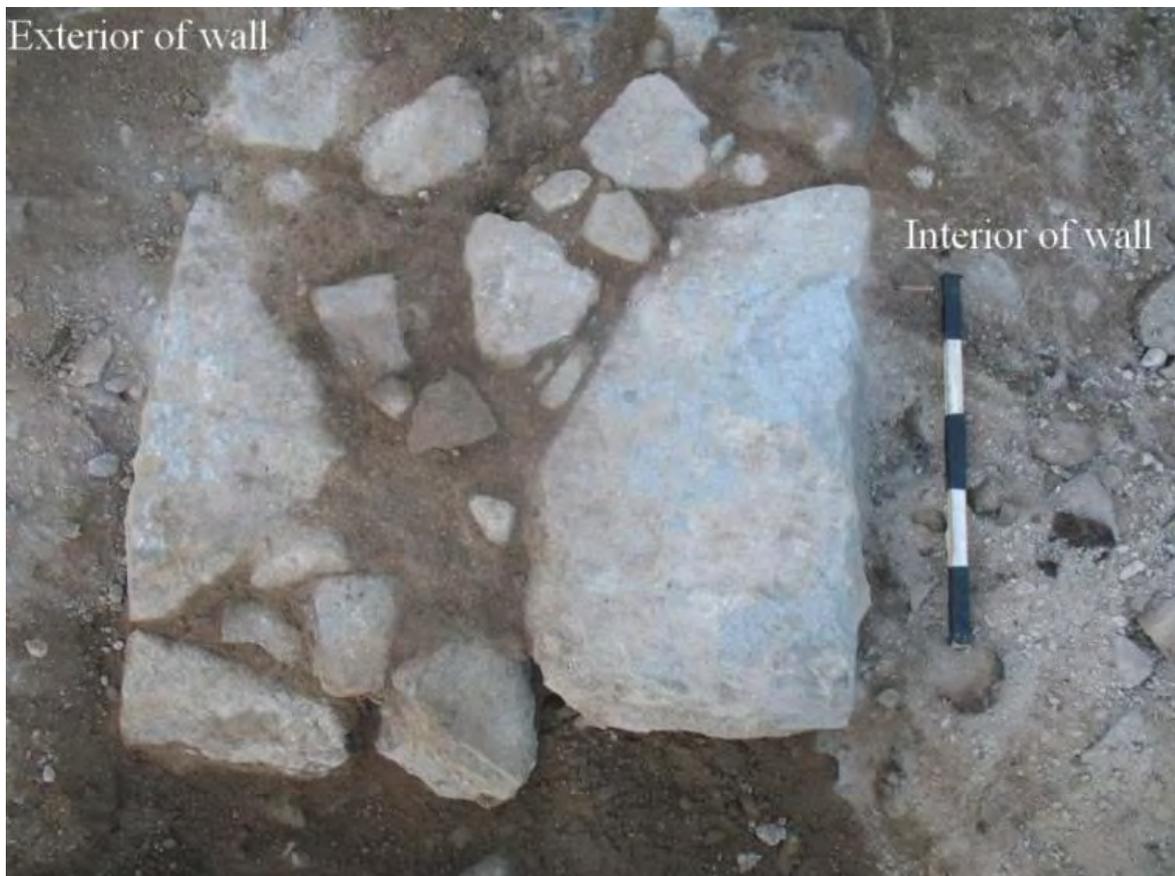
Figure 146. Plan view of the exposed foundations of the South (heritage) Wall

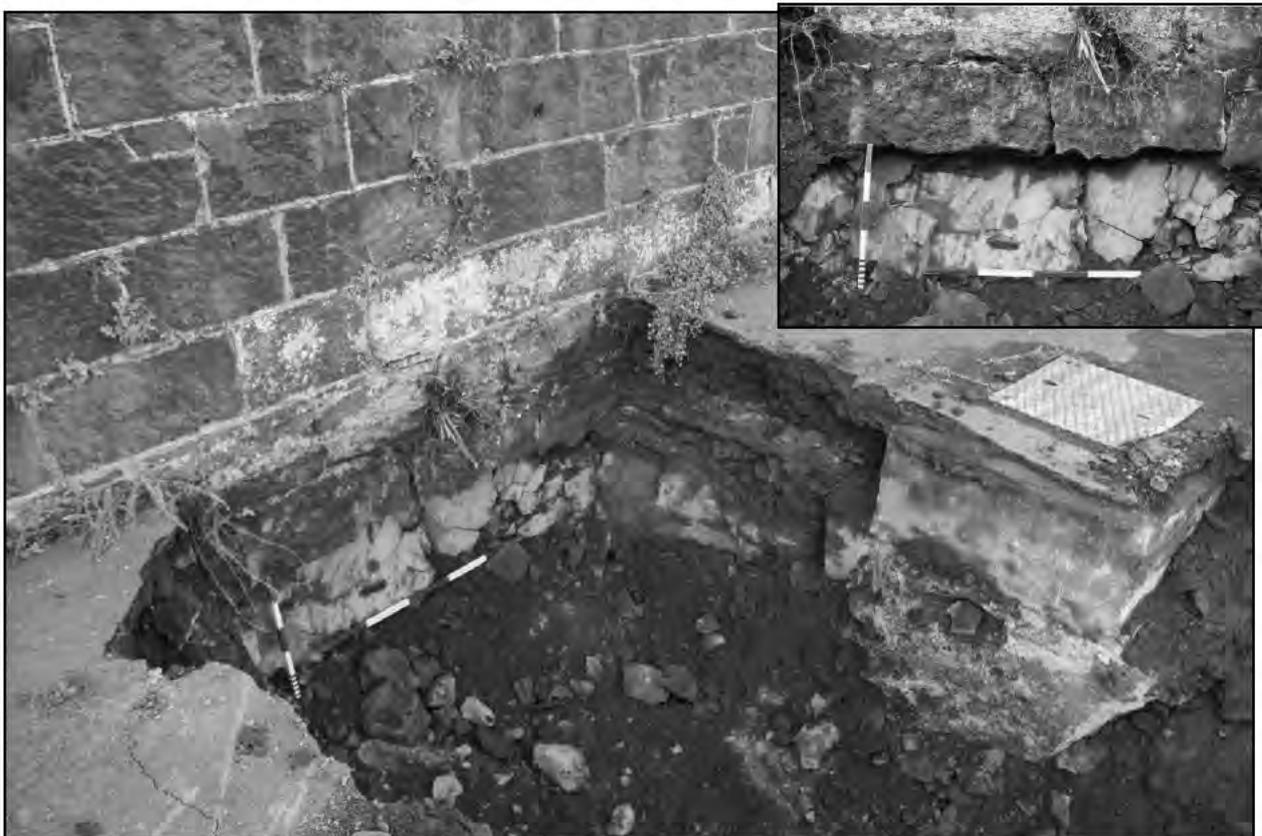
Figure 154. Stratigraphy of test pit next to East Wall

Trenching along the East Wall was carried out as part of work in the South-East Yard (see Chapter 6). While much of the work did not really impact on this part of the wall, some of the trenching did expose the foundations of the stone wall. As this was part of the original wall, the stratigraphy was recorded (Figure 154) and showed that the wall was built directly onto the basalt bedrock. In the interior section, it was also possible to see the build up of scoria and asphalt layers in the South-East Yard (around 50cm deep).

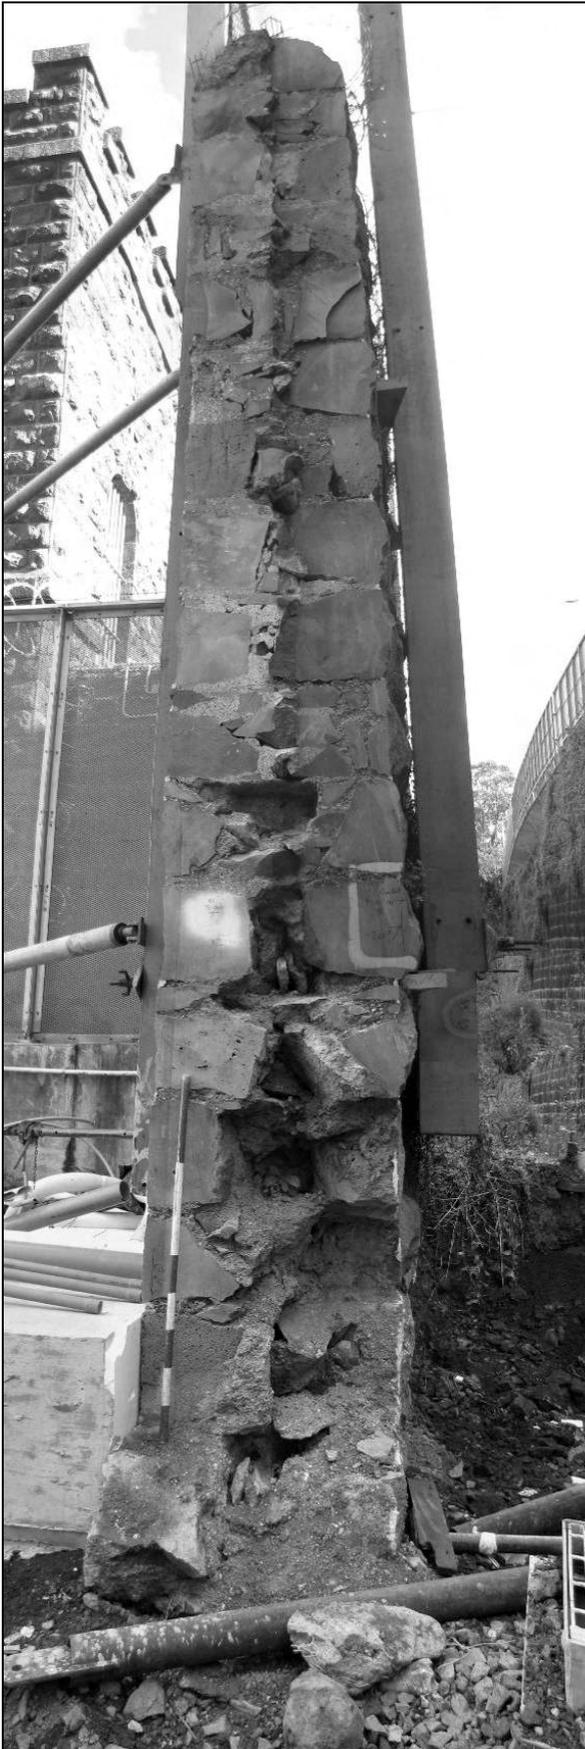
Figure 155. Cross-section through East Wall

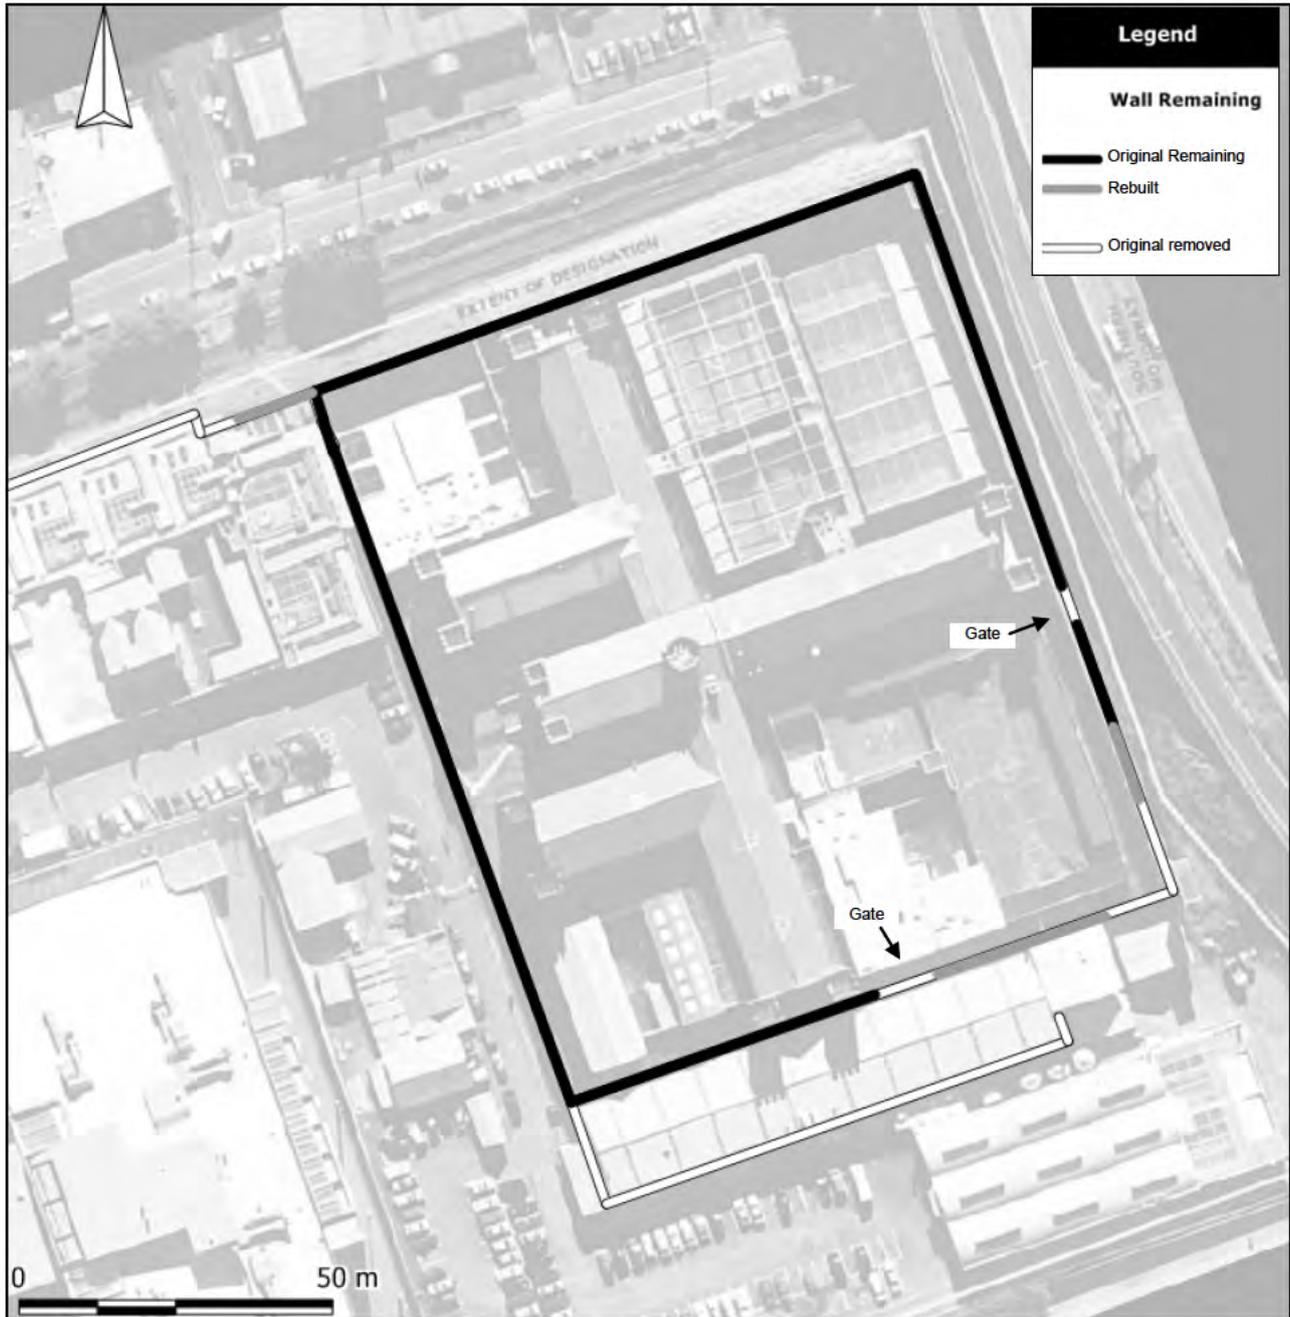
Figure 164. View of changes to the Heritage Wall

The finishing of most of the wall blocks was left rough, but provided little assistance for climbing. However, smoothed blocks appeared in many locations, particularly on the exterior of the South Wall when it was part of the workshops there. A variety of minor modifications occur along many of the walls relating to a range of activities, although mostly along the southern side. Changes to entrances also occurred, with old doors blocked up and others added.

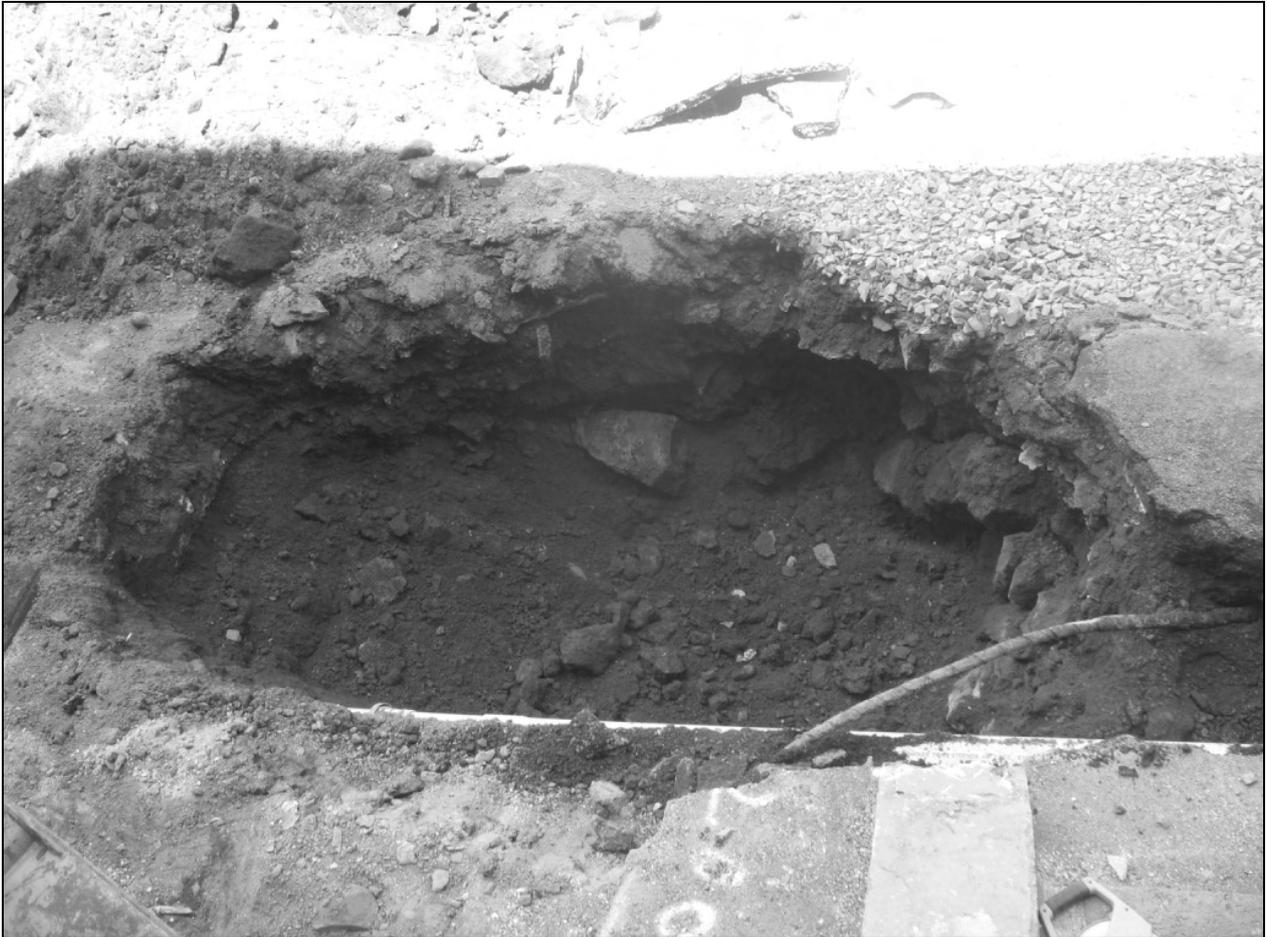
Figure 182. View towards the southern baulk of the sump pit with two rectangular stones associated with the Stockade period just visible

the excavated pit, stones relating to the Stockade period were noted in the southern baulk at a depth of 30cm and 40cm. The long rectangular stones had previously been noted during the Gymnasium excavation, but were identified higher in the stratigraphy than the examples seen in the sump pit (Figure 182), suggesting they may have been disturbed during previous works in the yard. At a depth of 80cm solid rock was encountered, necessitating the use of a rock breaker.

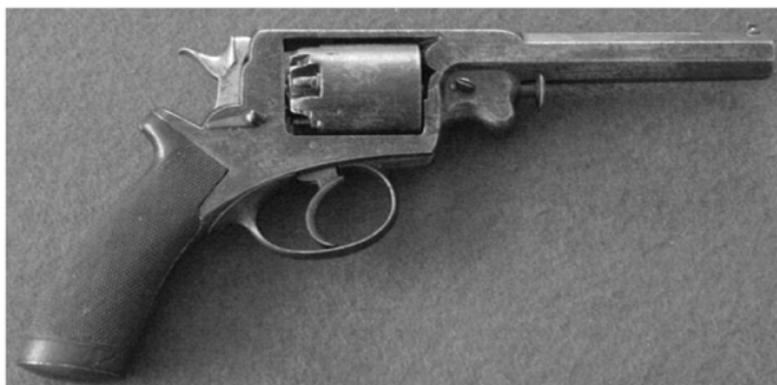
Figure 194. Bullet (left, item 114) from Beaumont-Adams revolver (courtesy David Rudd)

The 1853 Tranter revolver solved this problem with a rather ingenious double-trigger and safety mechanism, allowing rapid double action fire and more precise single-action shooting. The New Zealand Forest Rangers were equipped with Tranter, Colt Navy and Beaumont-Adams revolvers (Stowers 1996:271). In 1856, Frederick Beaumont went into partnership with Robert Adams, and they produced the Beaumont-Adams revolver, which included a traditional hammer and a double-action mechanism, much like a modern revolver, allowing both single and double action fire without the complexity of the Tranter. It rapidly became the revolver of choice for British officers and the British army in general, and Samuel Colt was forced to close down his London Factory only 4 years after opening it (Blackmore 1961:253-256). The Beaumont-Adams revolver remained in use by the British and Colonial forces until the 1880s, when it was replaced by the Enfield and Webley revolvers. Many had been converted to fire rimfire cartridges in that period, no longer being cap and ball revolvers.

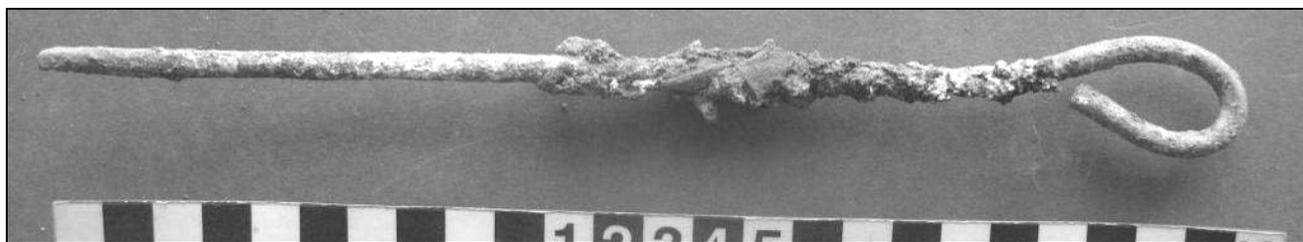
Figure 197. Stake from the demolition fill (Bag 112)

Three types of stakes were identified. Two were iron bars with no distinguishing features, except for one end shaped to a point. These were found in the upper layers. They differed as one had a square x-section (measuring 450mm in length and 13mm in diameter) and the other a circular x-section (measuring 440mm in length and 15mm in diameter). The other stake was recovered from the demolition fill (Bag 112) and had the appearance of a modern tent peg constructed of steel wire with one end formed into a loop (Figure 197). It measured 240mm in length with a diameter of 5mm.

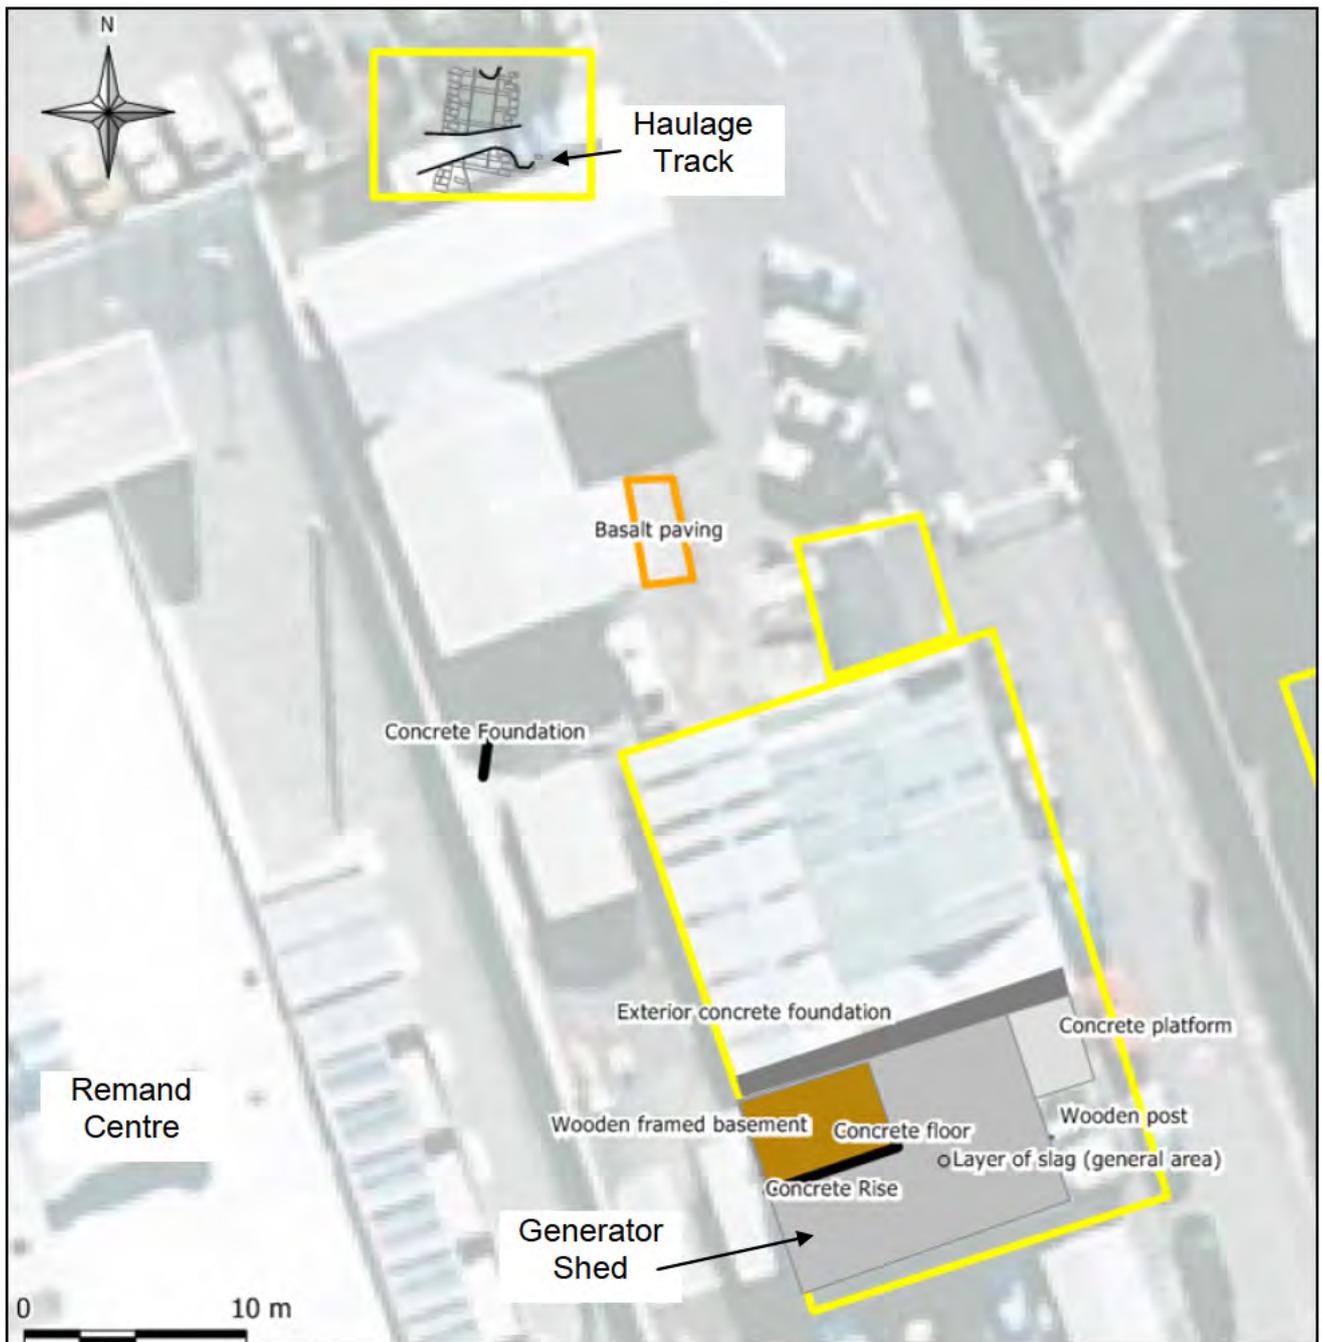
Figure 201. Plan showing main archaeological features uncovered near the Generator Shed

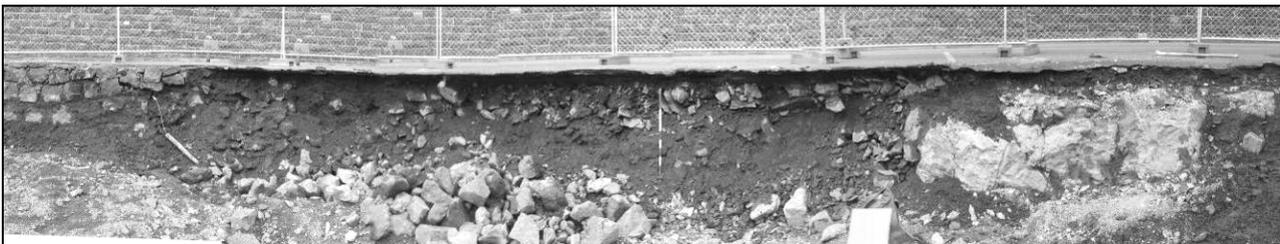
Figure 204. Section in front of Prison wall to the north of the Generator Shed

Demolition fill that had been shifted towards the eastern half of the area to create a flat area next to the main Prison wall was also visible in section (Figure 204). This had already been noted during the recording of the Tallyman's Hut and the Generator Shed. It contained no major artefacts and probably dated the second half of the 20th century.

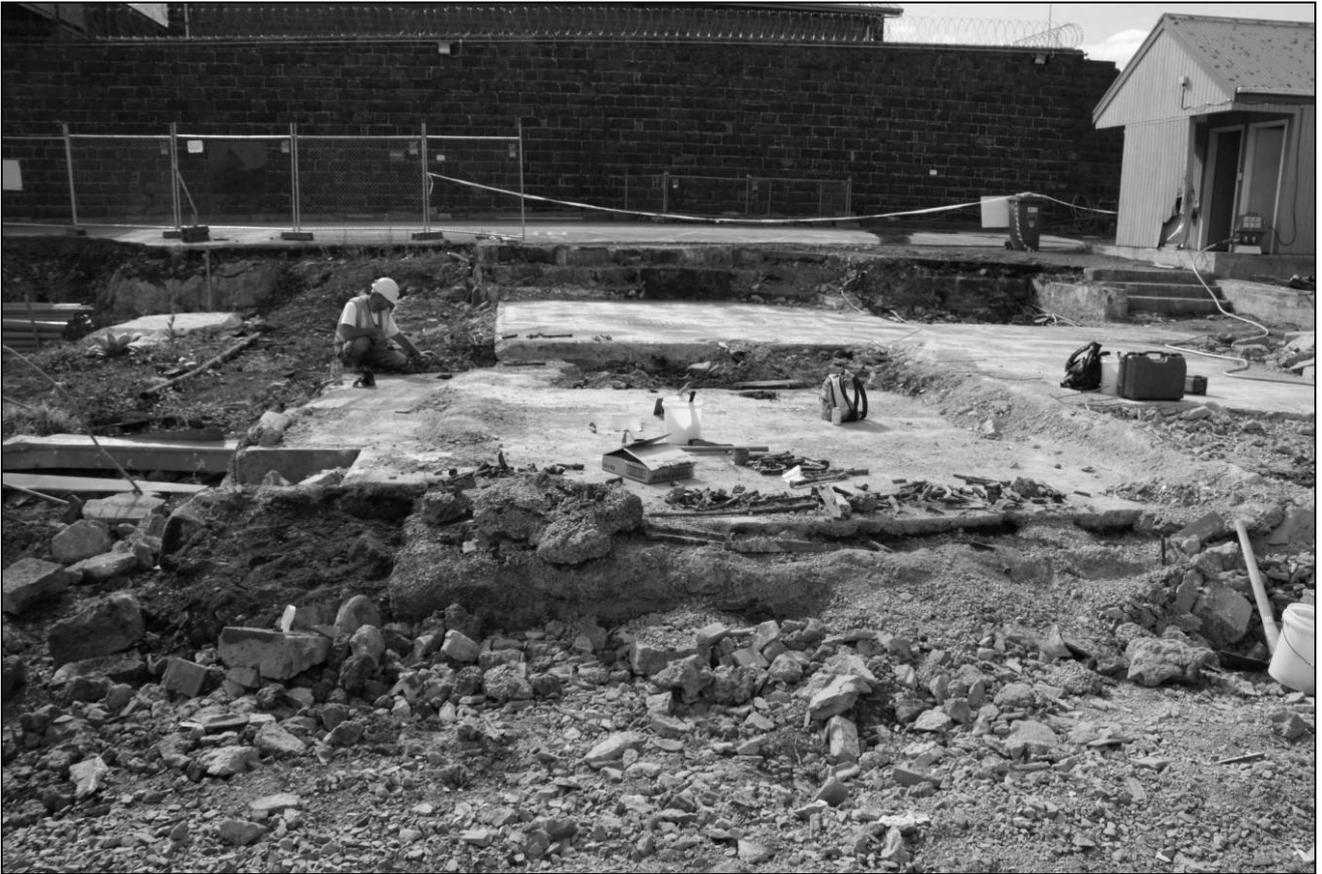
Figure 205. View of concrete foundations of Generator Shed looking east

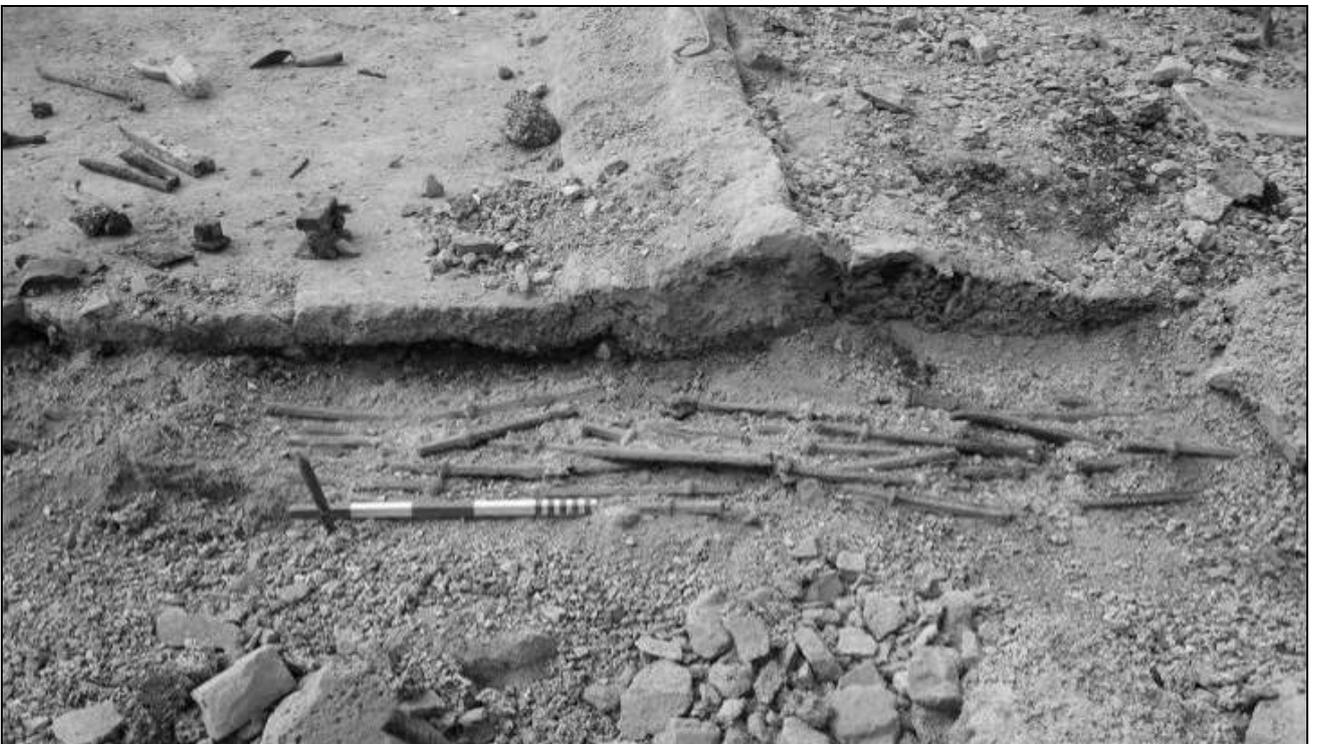
Figure 206. Drill bits laid out as steel reinforcing within the foundations of the building

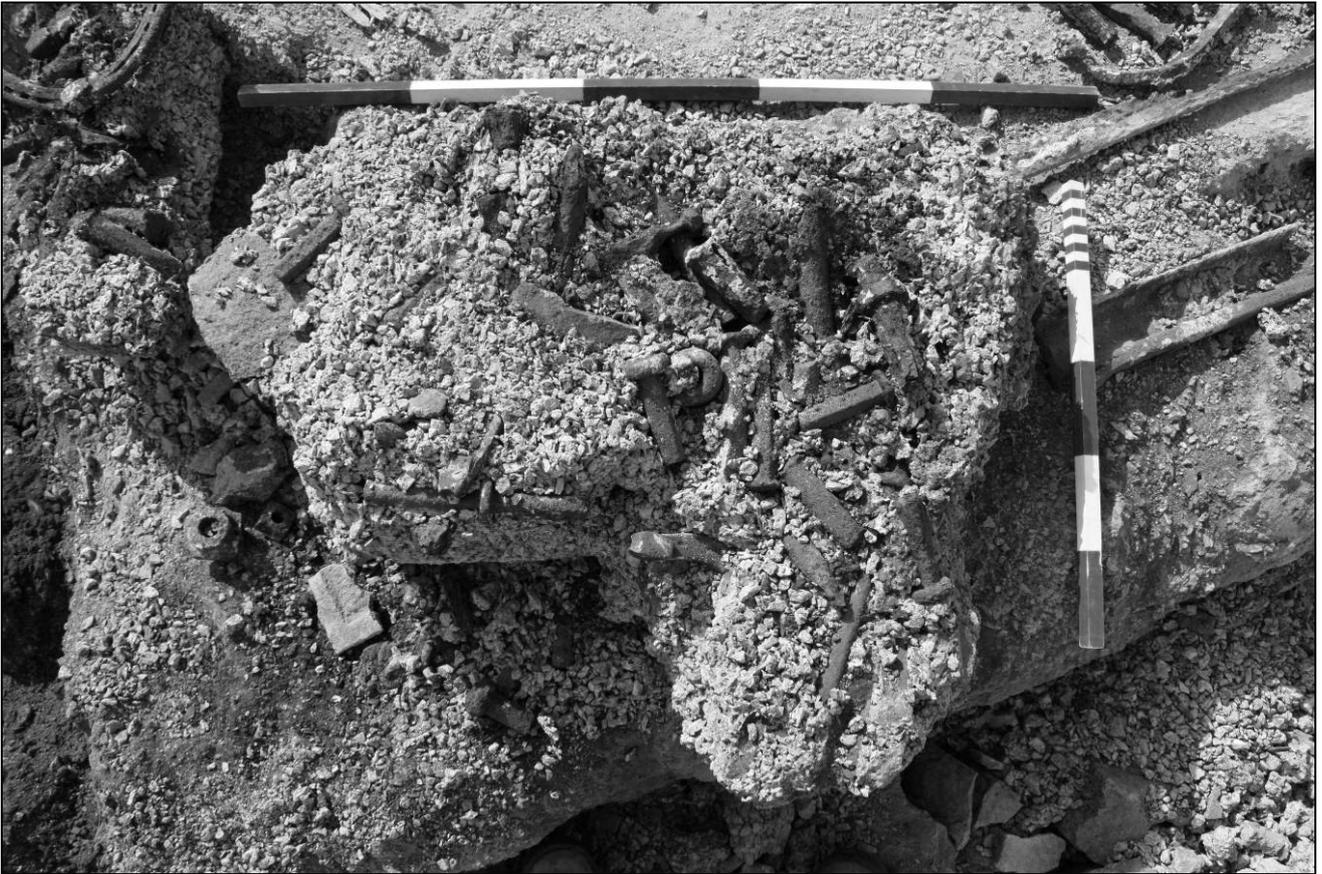
Figure 207. Close-up of embedded tools in concrete

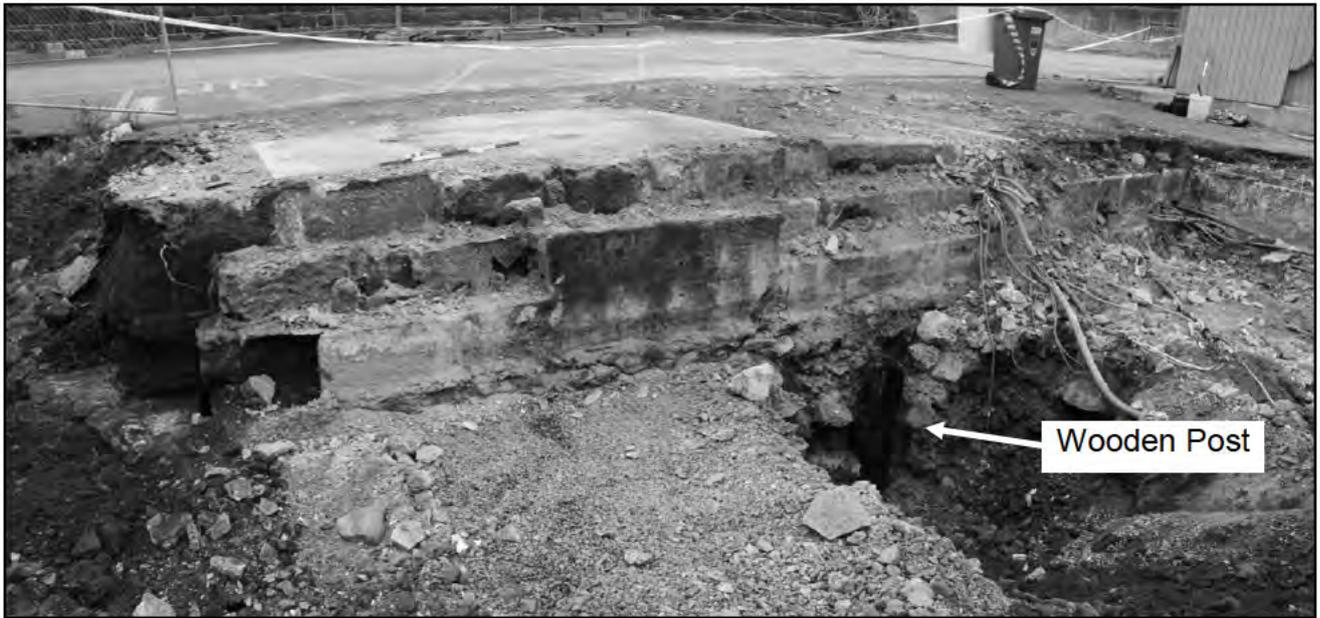
Figure 209. View of concrete foundations on east side of Generator Shed

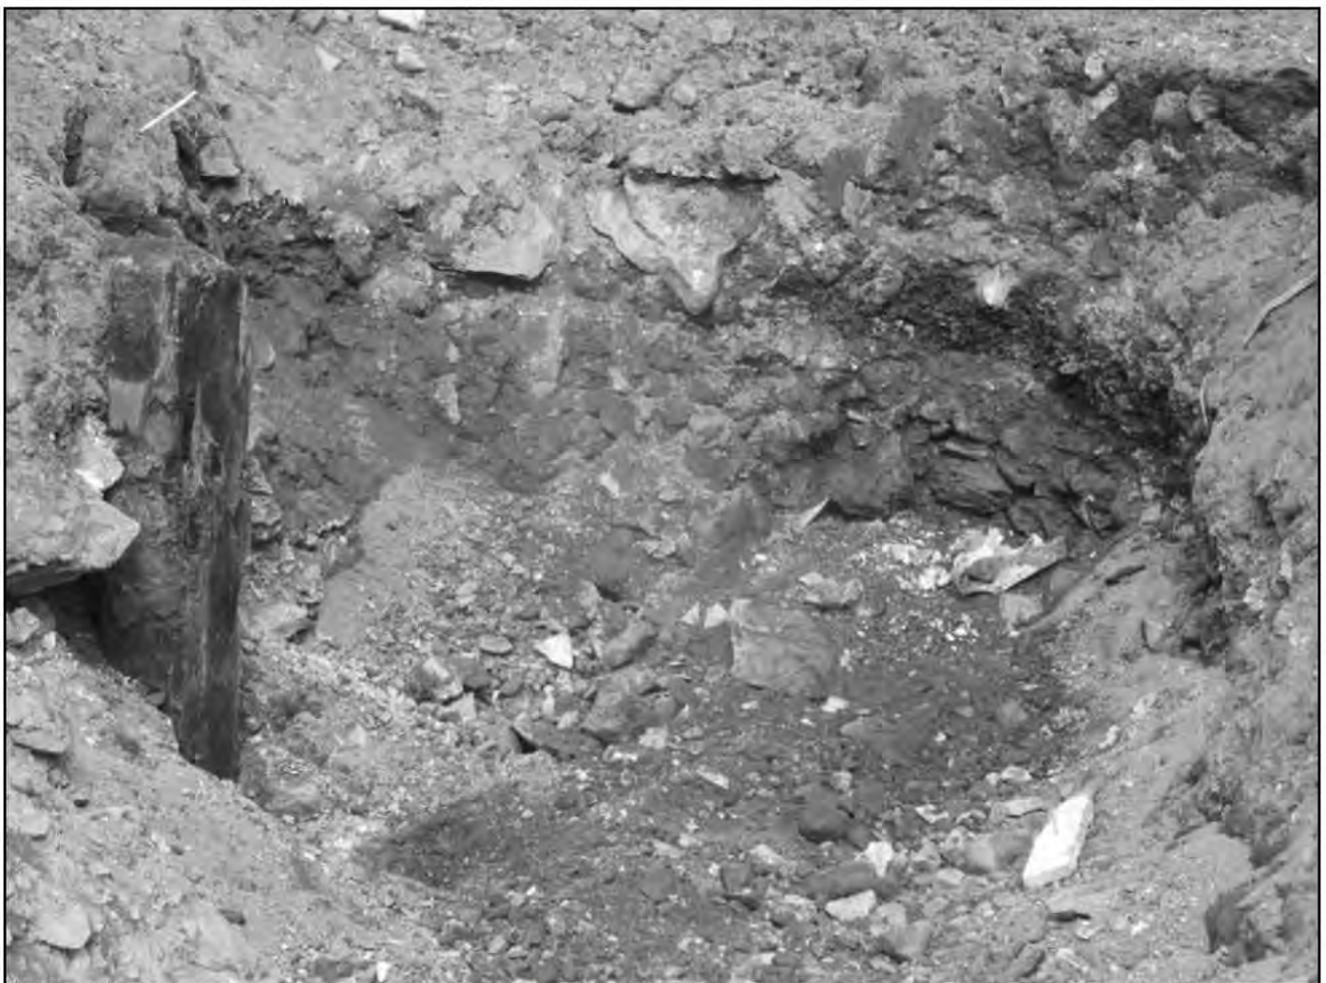
Figure 210. Wooden post and material deposits beneath the Generator Shed

In the south-west corner of the excavated area beneath the Generator Shed at a depth of 50cm was a 17cm layer of coal mixed with smithing slag (Figure 210). This slag included coal and vitrified ash and probably came from a nearby smithy. Beneath the coal and slag layer was an 8cm layer of stone fill. A 10cm layer containing brick and glass remains was immediately beneath the stone fill layer.

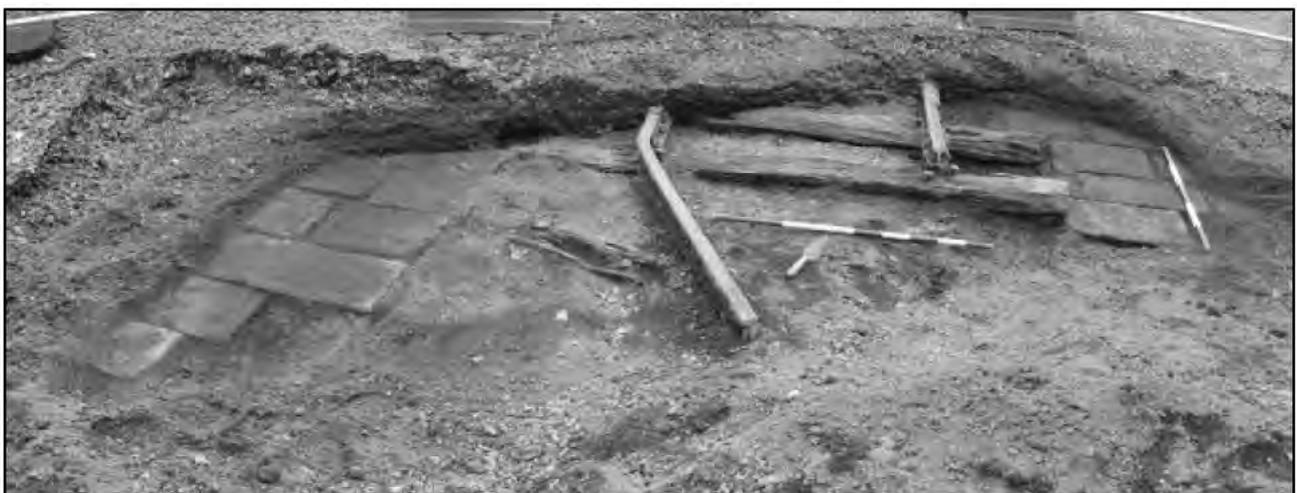
Figure 221. Exposed rail track found in front of entrance to Prison

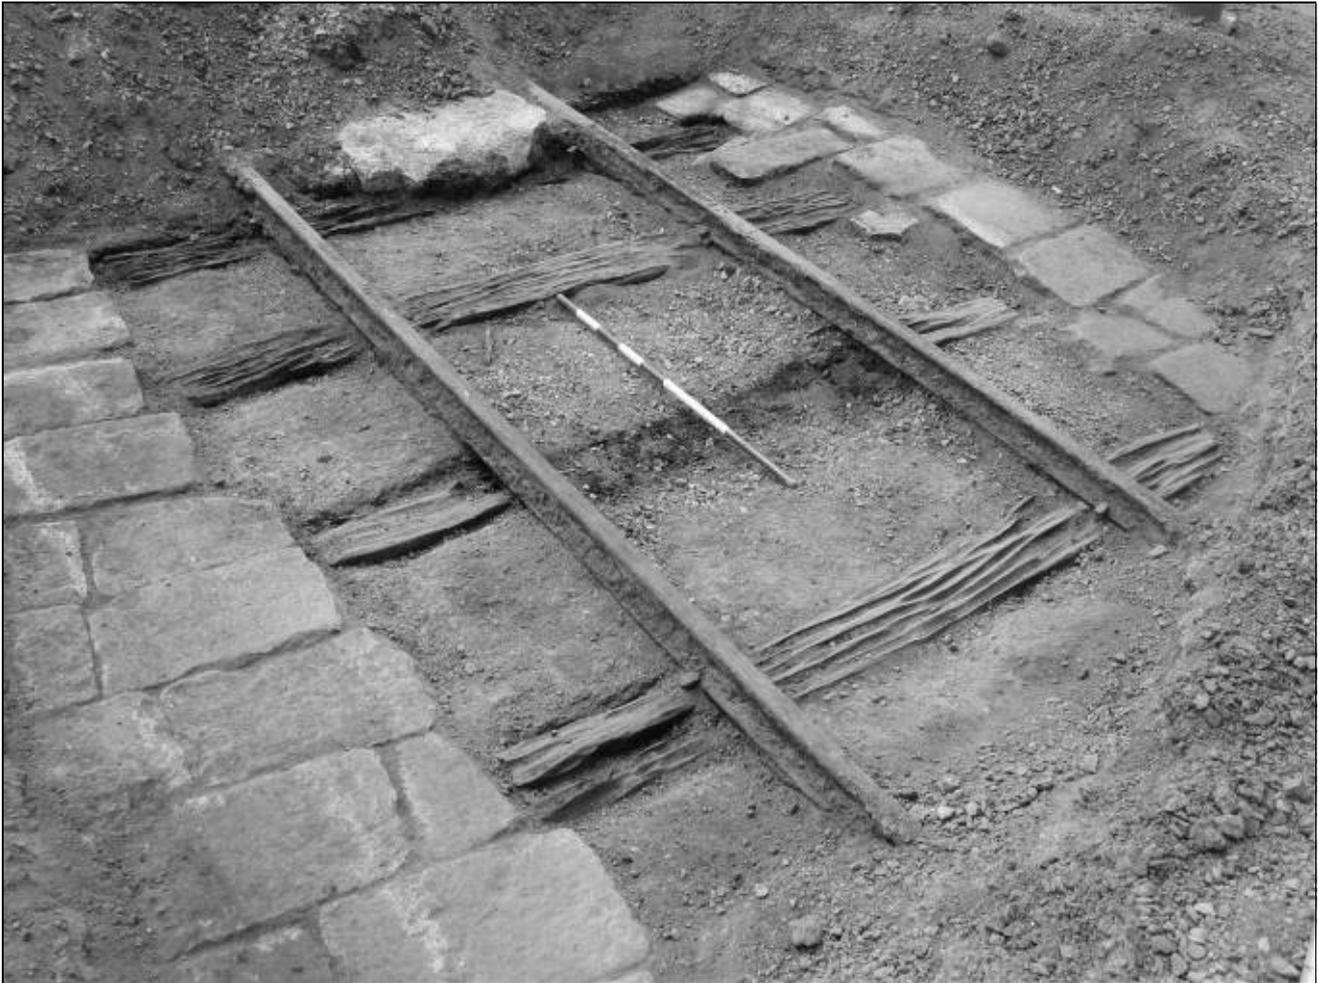
Figure 222. Exposed rail track found in front of entrance to Prison
