Doing Time at the Mount: Archaeological Investigations at Mt Eden Prison

Final report for NZHPT Authority
2008/144

Prepared for
Department of Corrections

October 2011

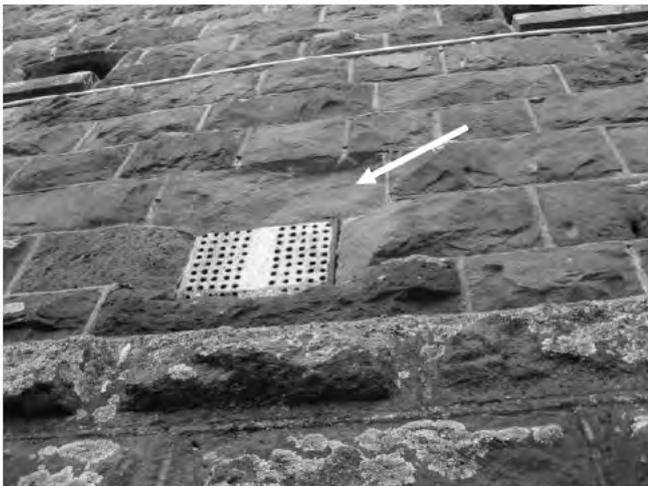
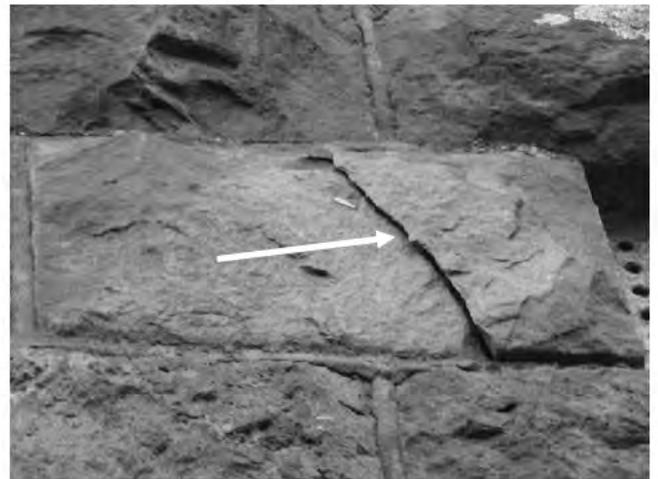
Figure 253. View of damage on the southern side of the central wing

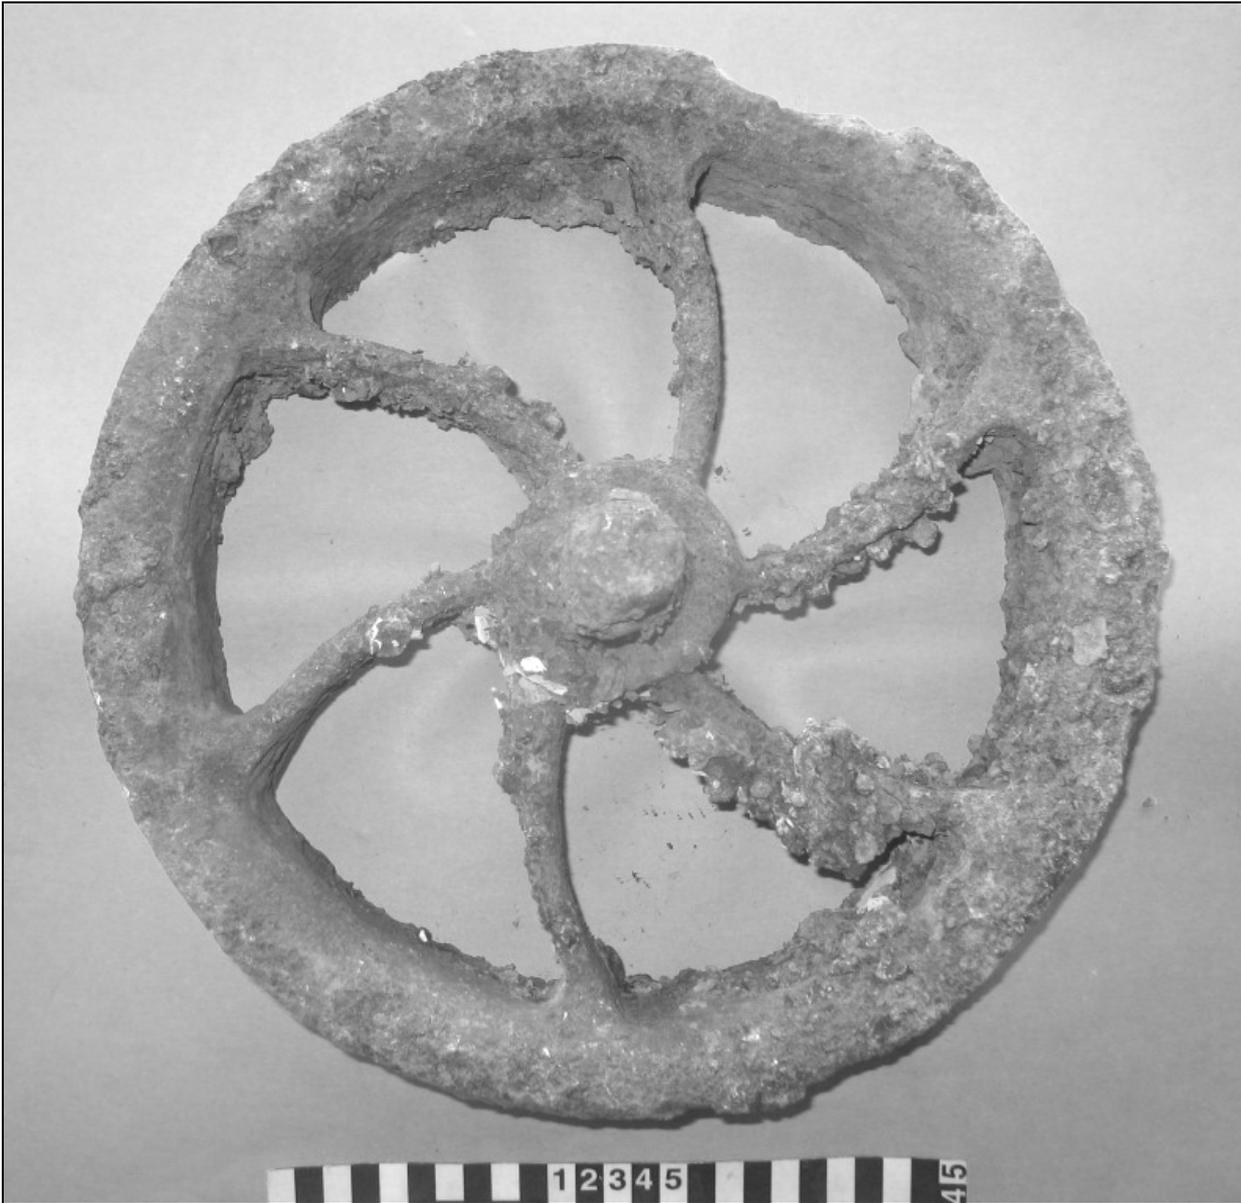
Figure 276. Rail carriage wheel recovered from south trench in Southern Carpark
